APPENDIX

Date: January 22, 2020

Subject: City of Bellingham Reservoirs Inspection and Repairs
Marietta Site

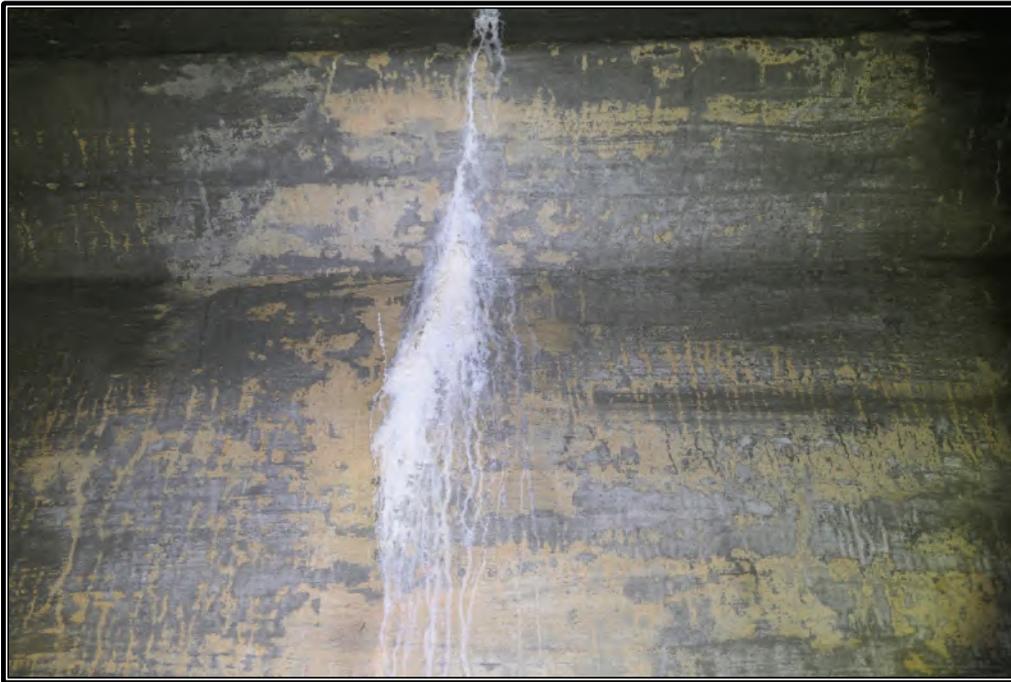
Figure 2-13: Sehome Reservoir - NW Wall, Cracking located in wall above sandstone outcropping

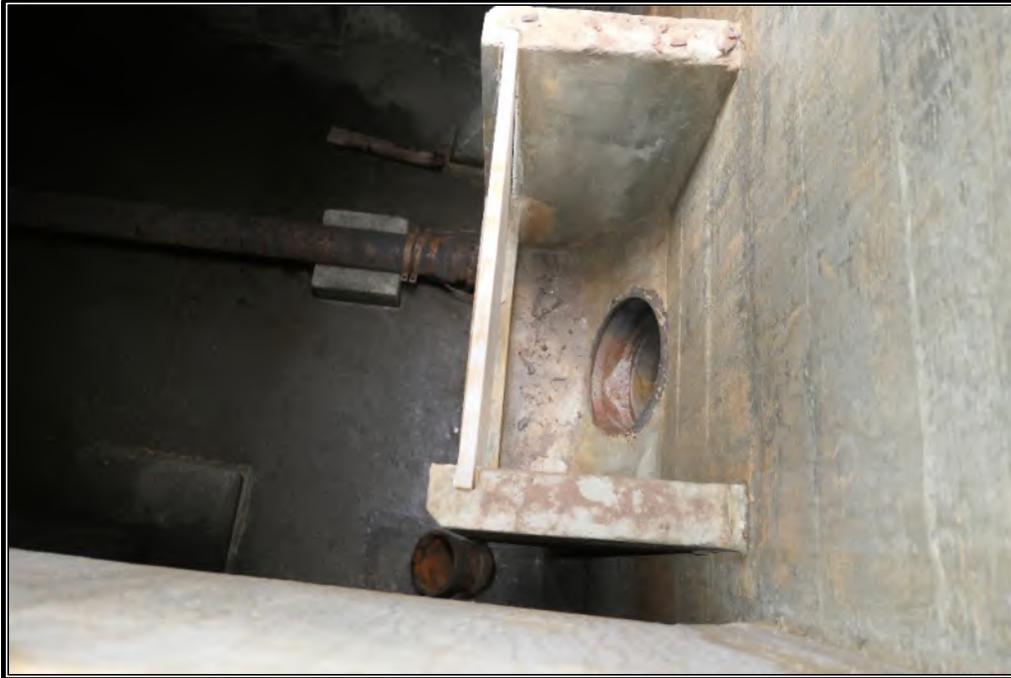
Figure 2-14: Sehome Reservoir - Overflow Weir

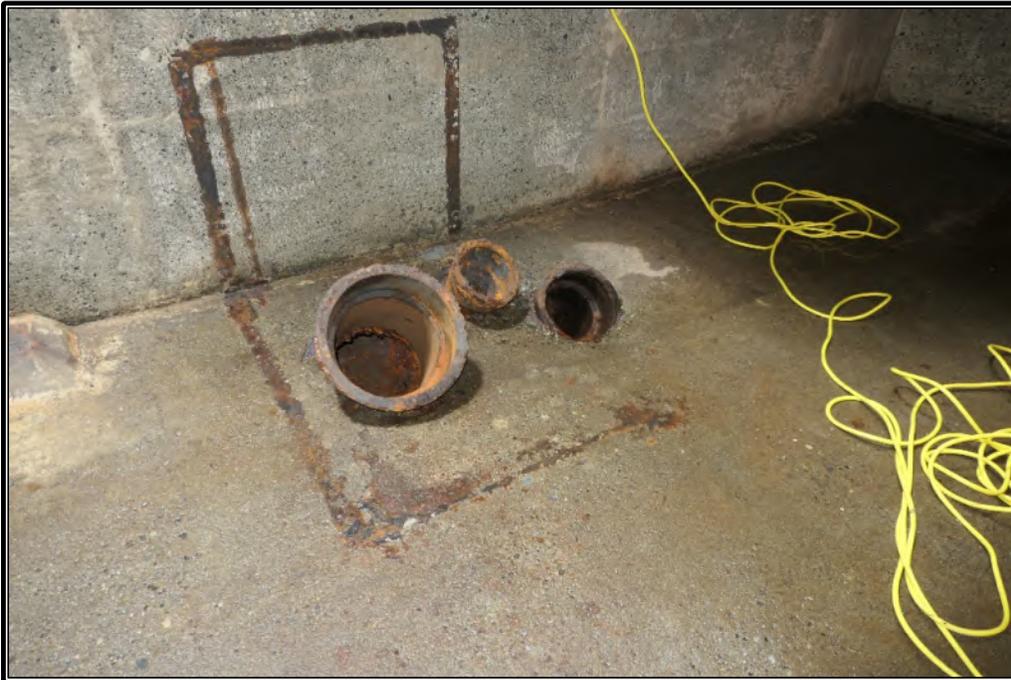
Figure 2-15: Sehome Reservoir - Inlet, Outlet, and Drain

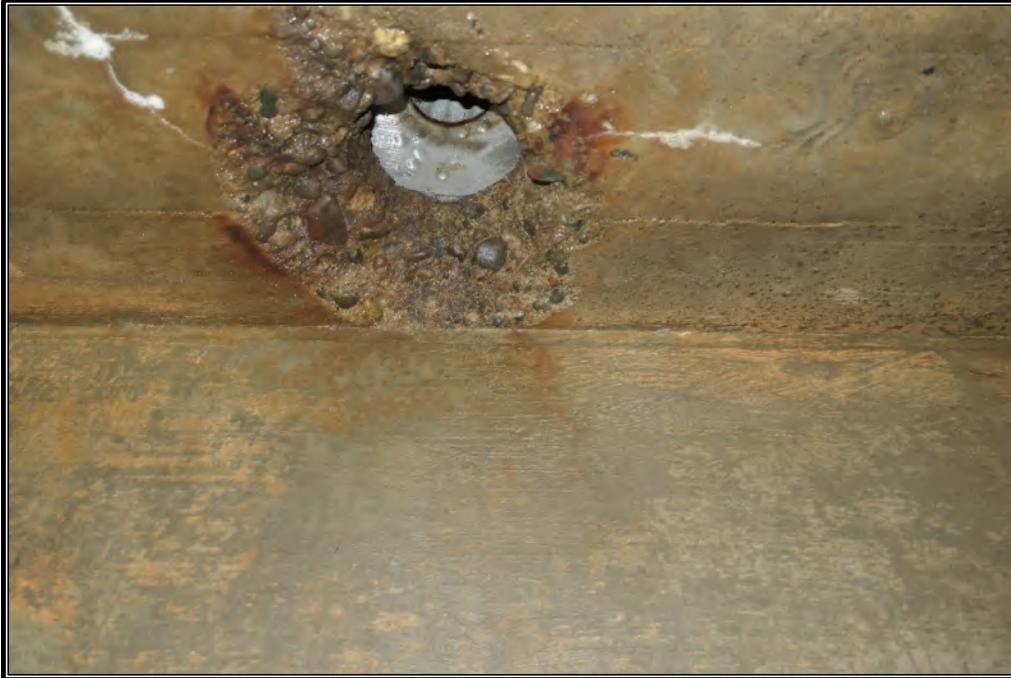
Figure 2-16: Sehome Reservoir - Location of roof concrete failure around vent located by SW hatch

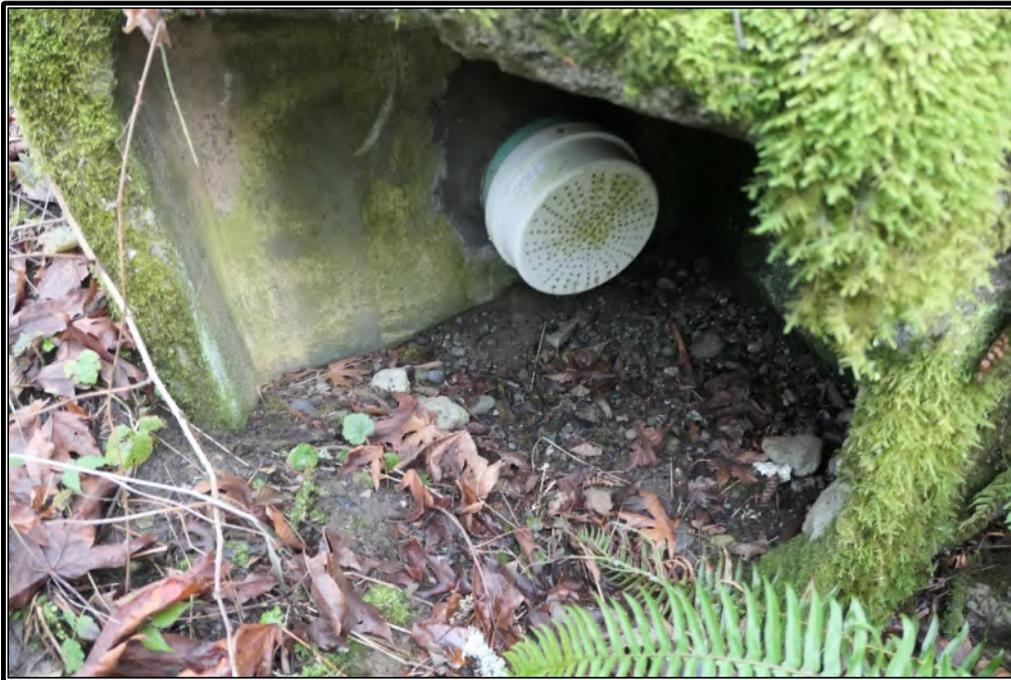
Figure 2-17: Sehome Reservoir - overflow outlets, SW of reservoir, protected by damaged concrete enclosure

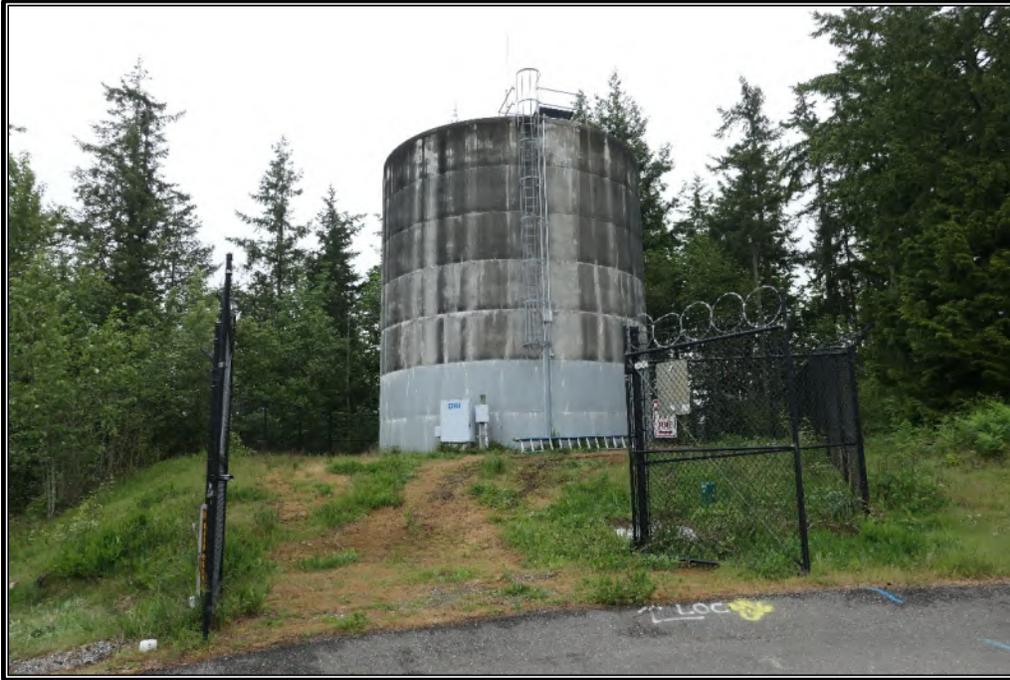
Figure 2-3: Parkhurst Reservoir – Elevation

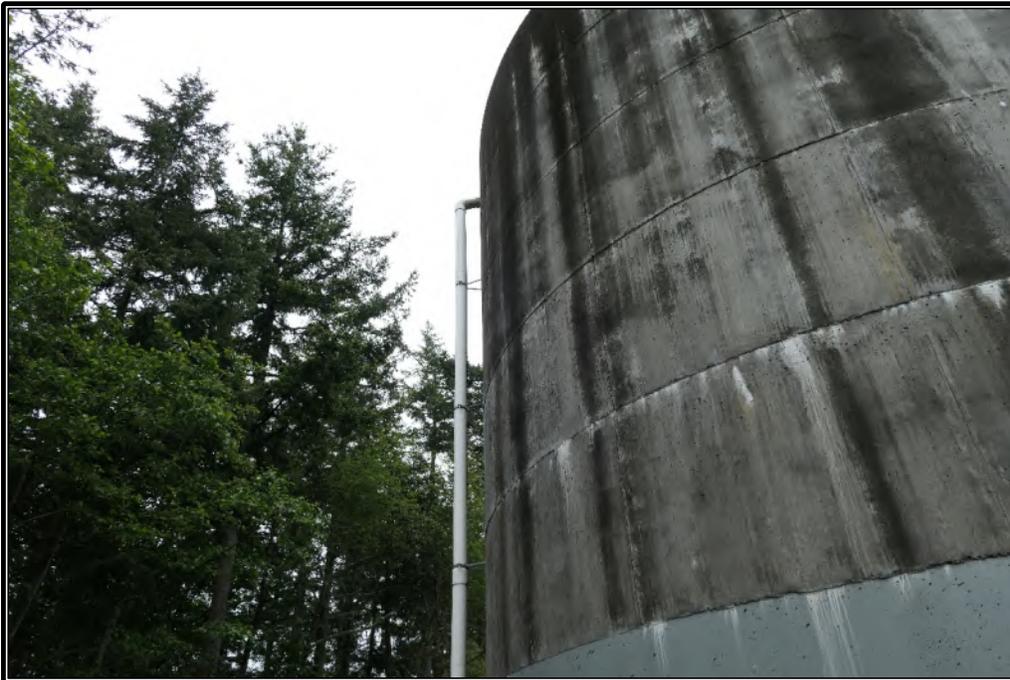
Figure 2-4: Parkhurst Reservoir – Overflow Pipe

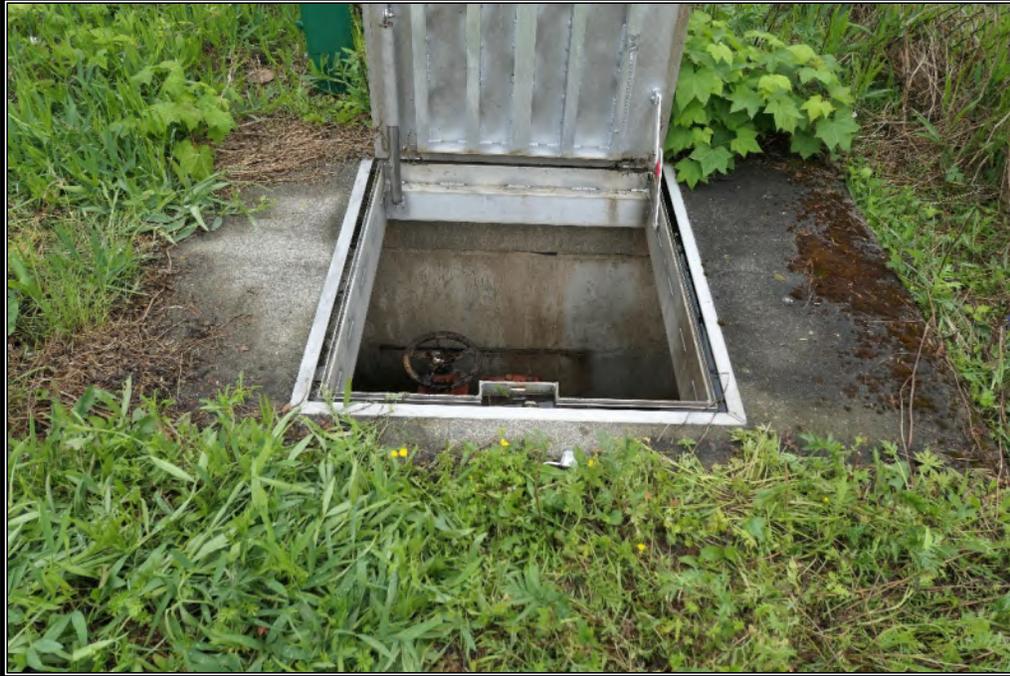
Figure 2-5: Parkhurst Reservoir – Entry to Valve Vault

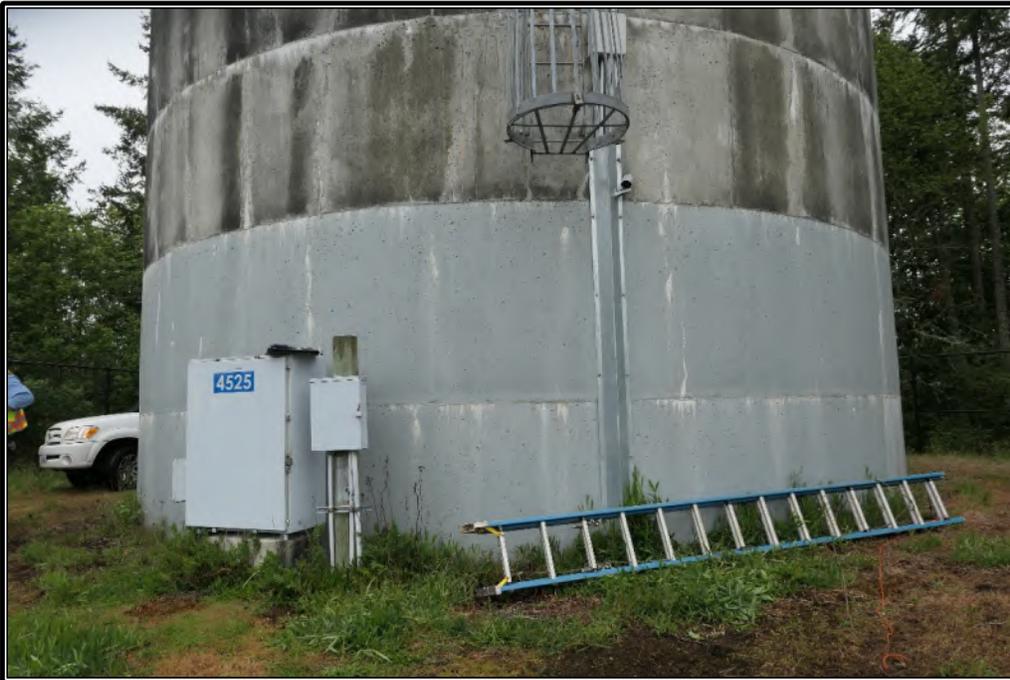
Figure 2-6: Parkhurst Reservoir – Lower Courses and Access Ladder

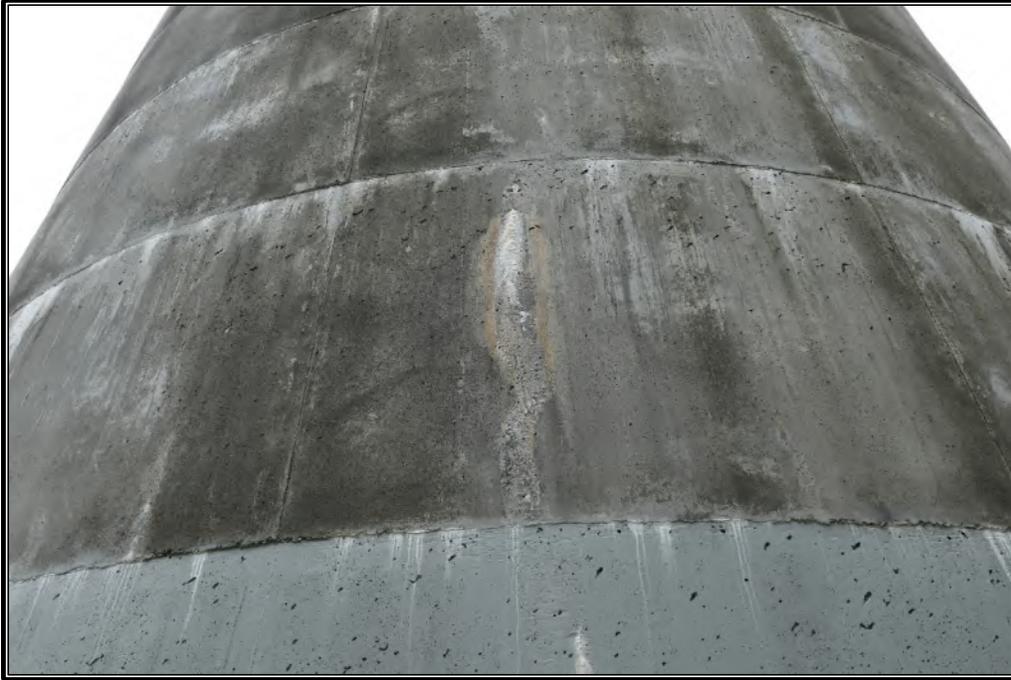
Figure 2-7: Parkhurst Reservoir – Cracking and Efflorescence (3rd Course)

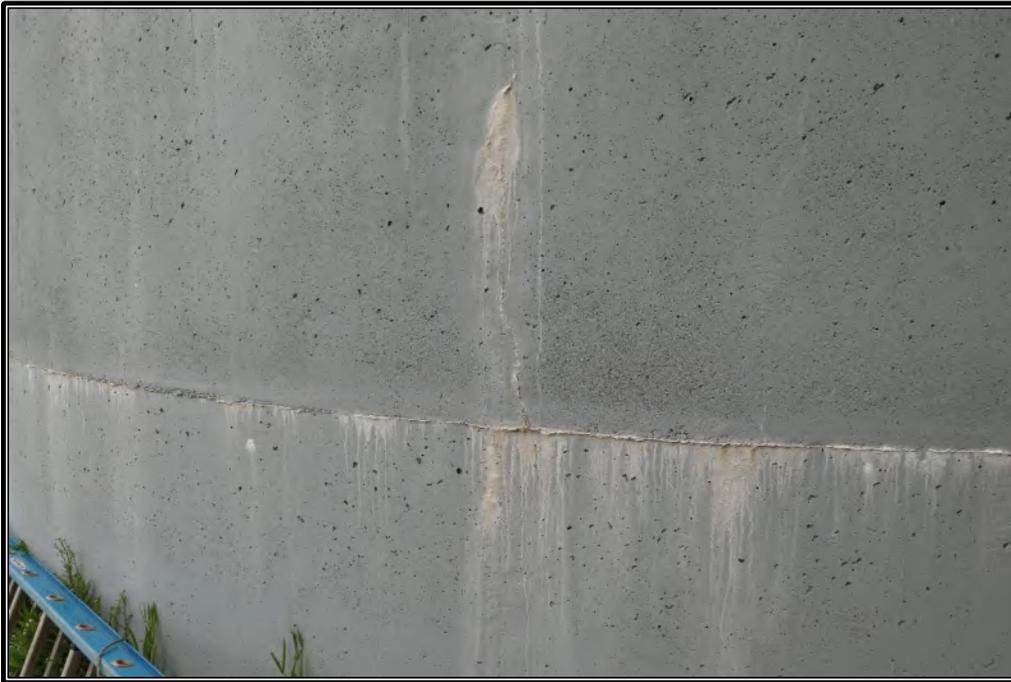
Figure 2-8: Parkhurst Reservoir – Vertical and Horizontal Cracking and Efflorescence (1st and 2nd Course)

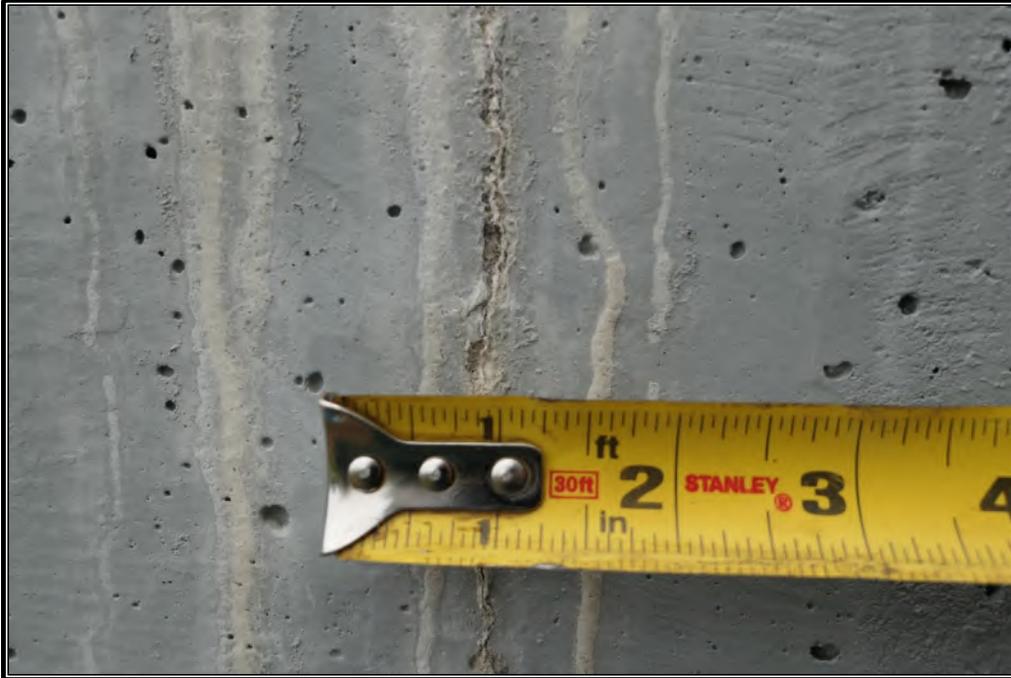
Figure 2-9: Parkhurst Reservoir – Close-up of Vertical Crack (Efflorescence Removed)

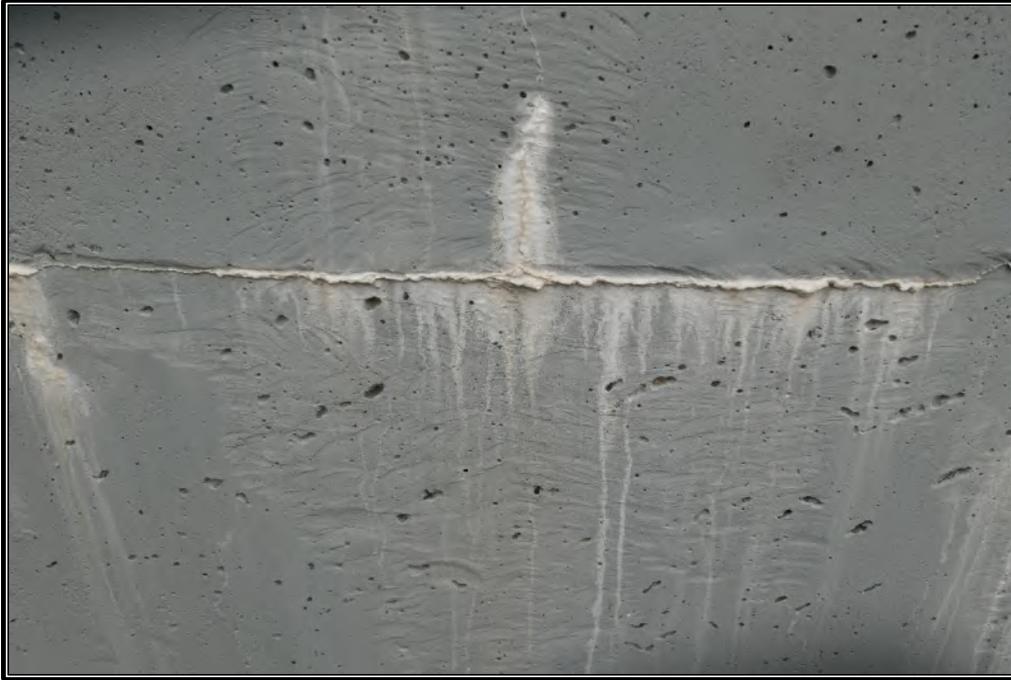
Figure 2-11: Parkhurst Reservoir – Vertical and Horizontal Cracking and Efflorescence (1st and 2nd Course)

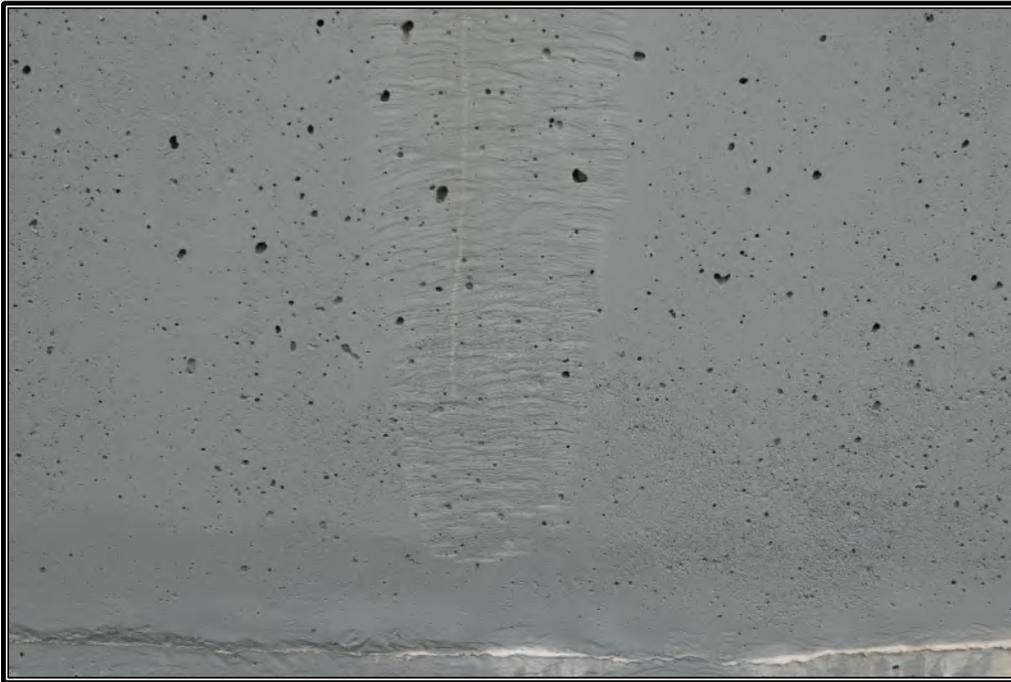
Figure 2-12: Parkhurst Reservoir –Marking on Concrete Indicative of Mechanical Abrasion used to Removed Efflorescence

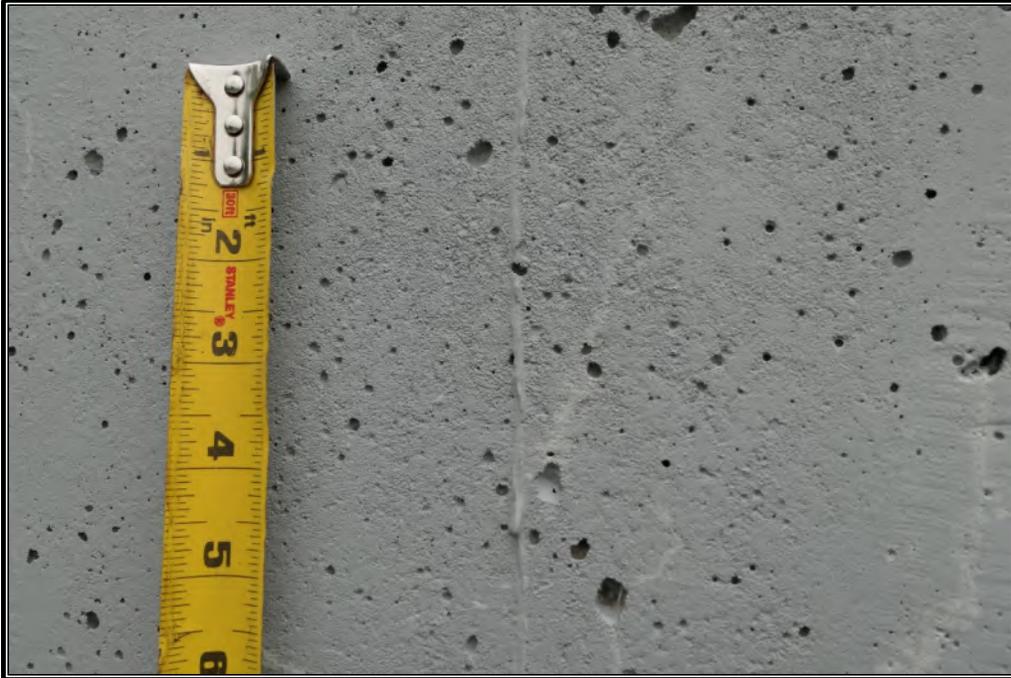
Figure 2-13: Parkhurst Reservoir – Bug-hole and Defect Density

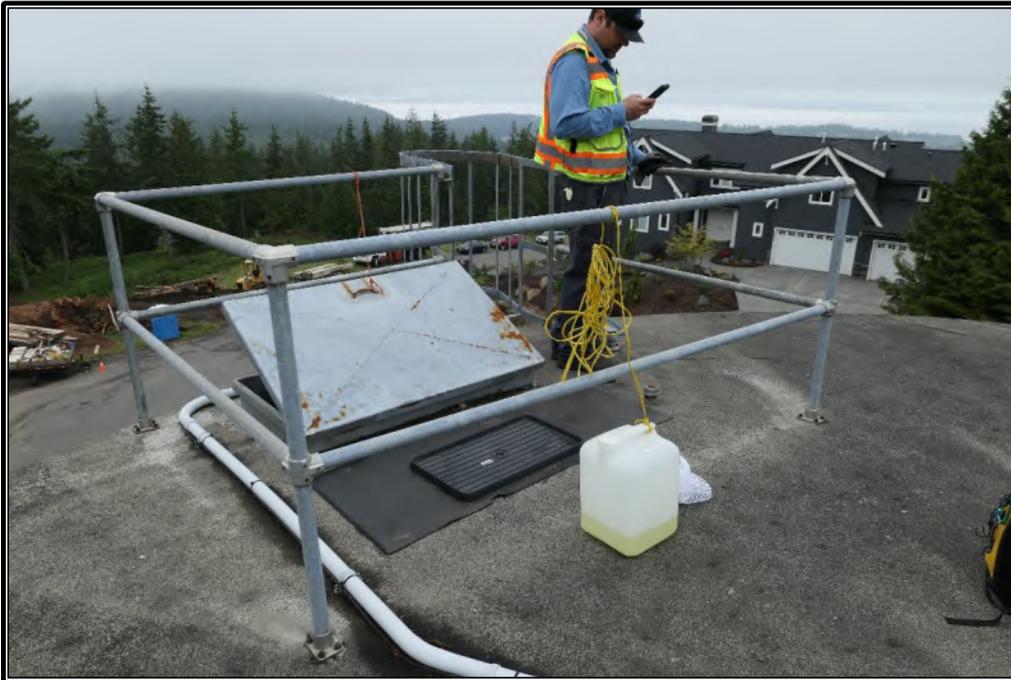
Figure 2-14: Parkhurst Reservoir – Roof Access Hatch

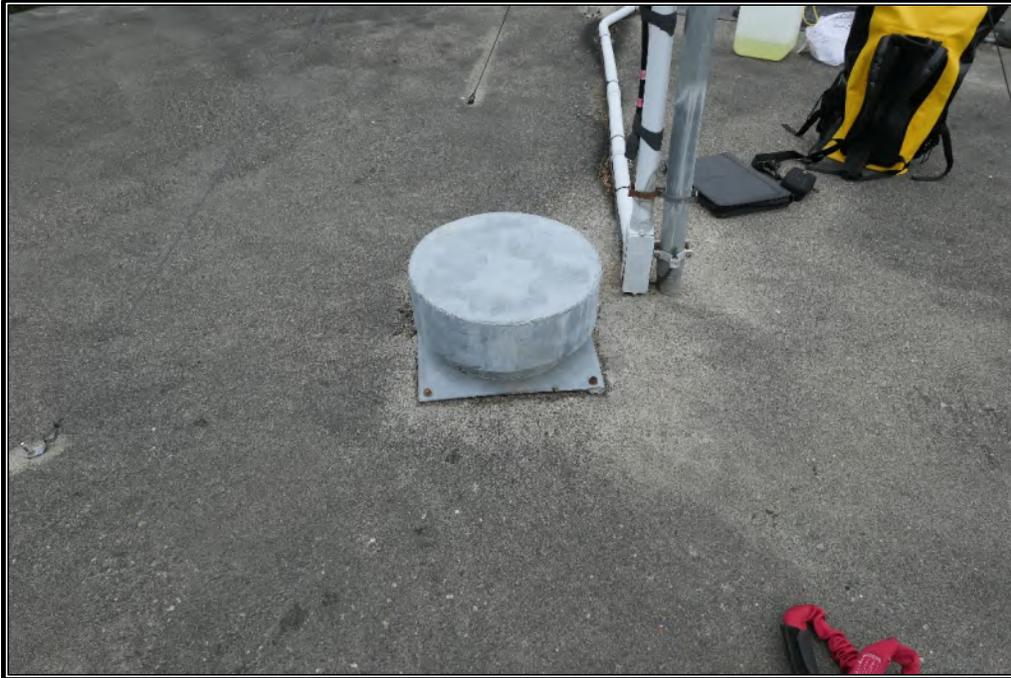
Figure 2-15: Parkhurst Reservoir – Roof Access Vent

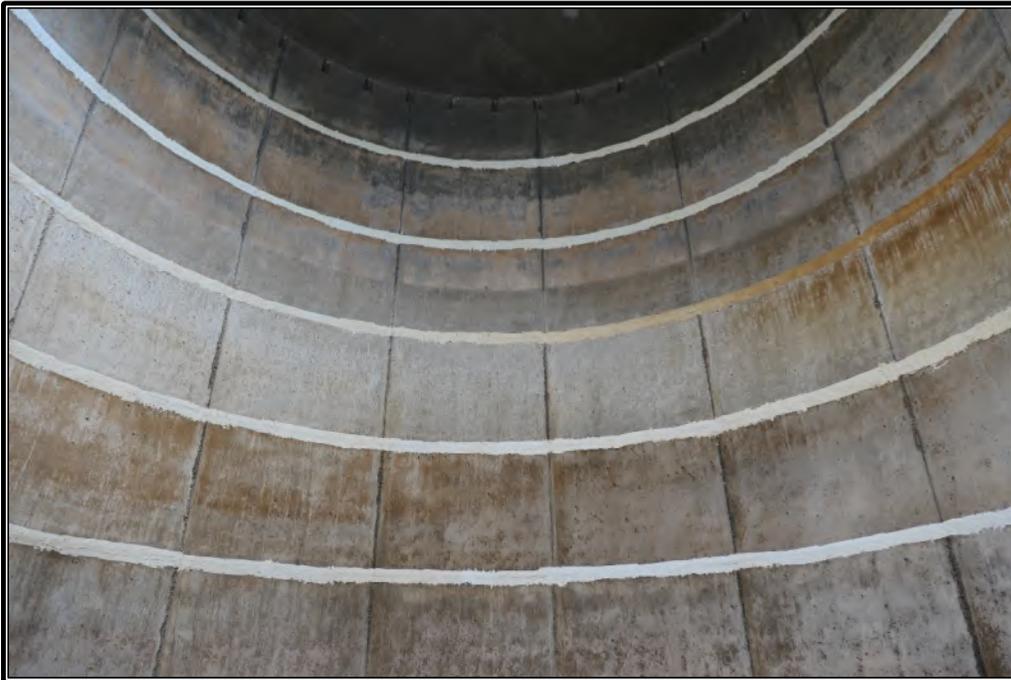
Figure 2-16: Parkhurst Reservoir – Interior Wall
