# Part 2: Table of Contents

## Part 2: Conditions Assessment

# Conditions Assessment Results

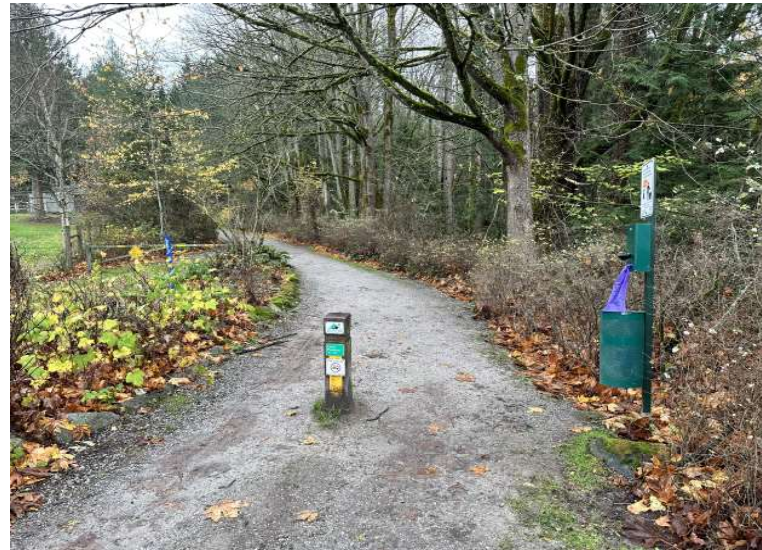
36th Street trail head.

- Enhance trail head signage at trailhead and way-finding from the neighborhood to the trailhead.
- Enhance parking opportunities at the 36th Street trailhead with community buy-in.
- Improve fish barrier.

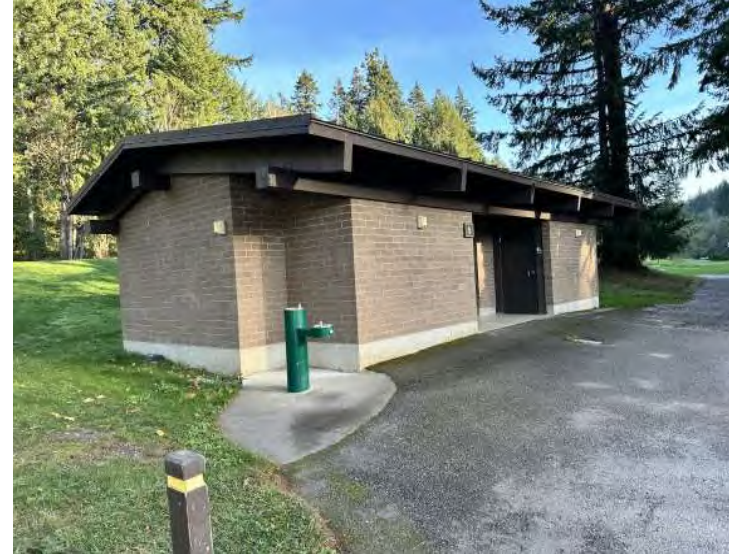
Eastern bathroom facility.

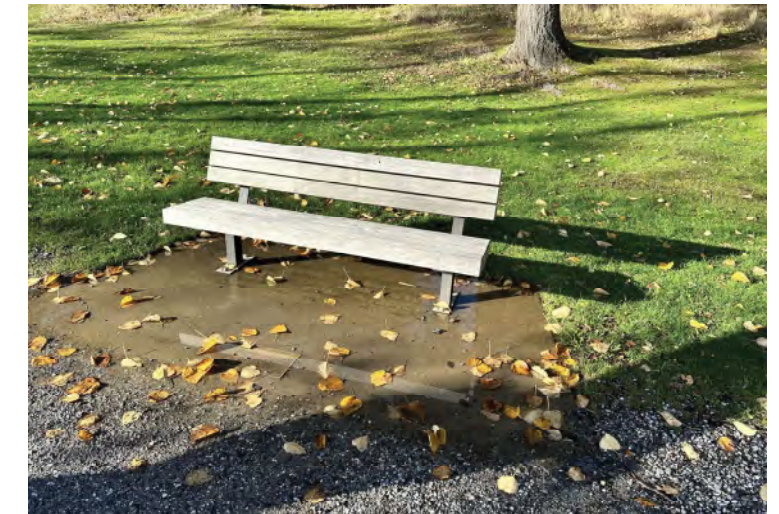
Bench pads do not allow for ADA seating adjacent.
