# City of Bellingham Screen House: Condition Assessment and Improvement Report (Task 3.8)

PREPARED FOR: City of Bellingham Project Team  
PREPARED BY: CH2M HILL Project Team  
DATE: November 7, 2014

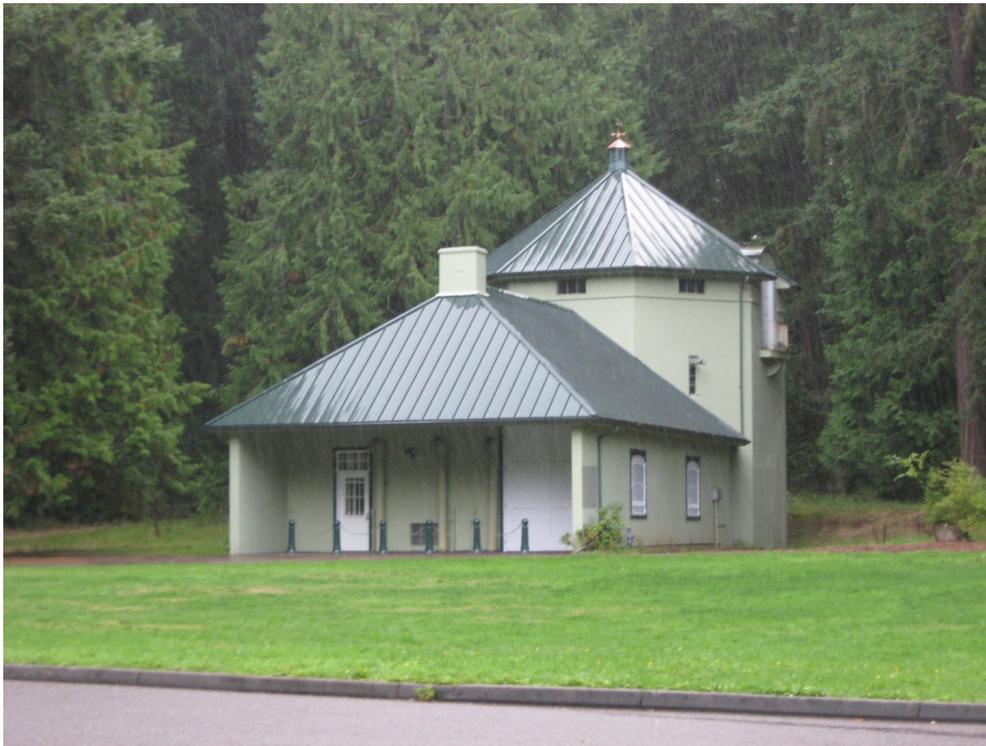
**Exhibit 1-1. Screen House**

The City of Bellingham (City) undertook an assessment of the condition of the existing Screen House facility (pictured below in Exhibit 1-1). The condition assessment, as presented herein, covers several key aspects of the Screen House facility, including:

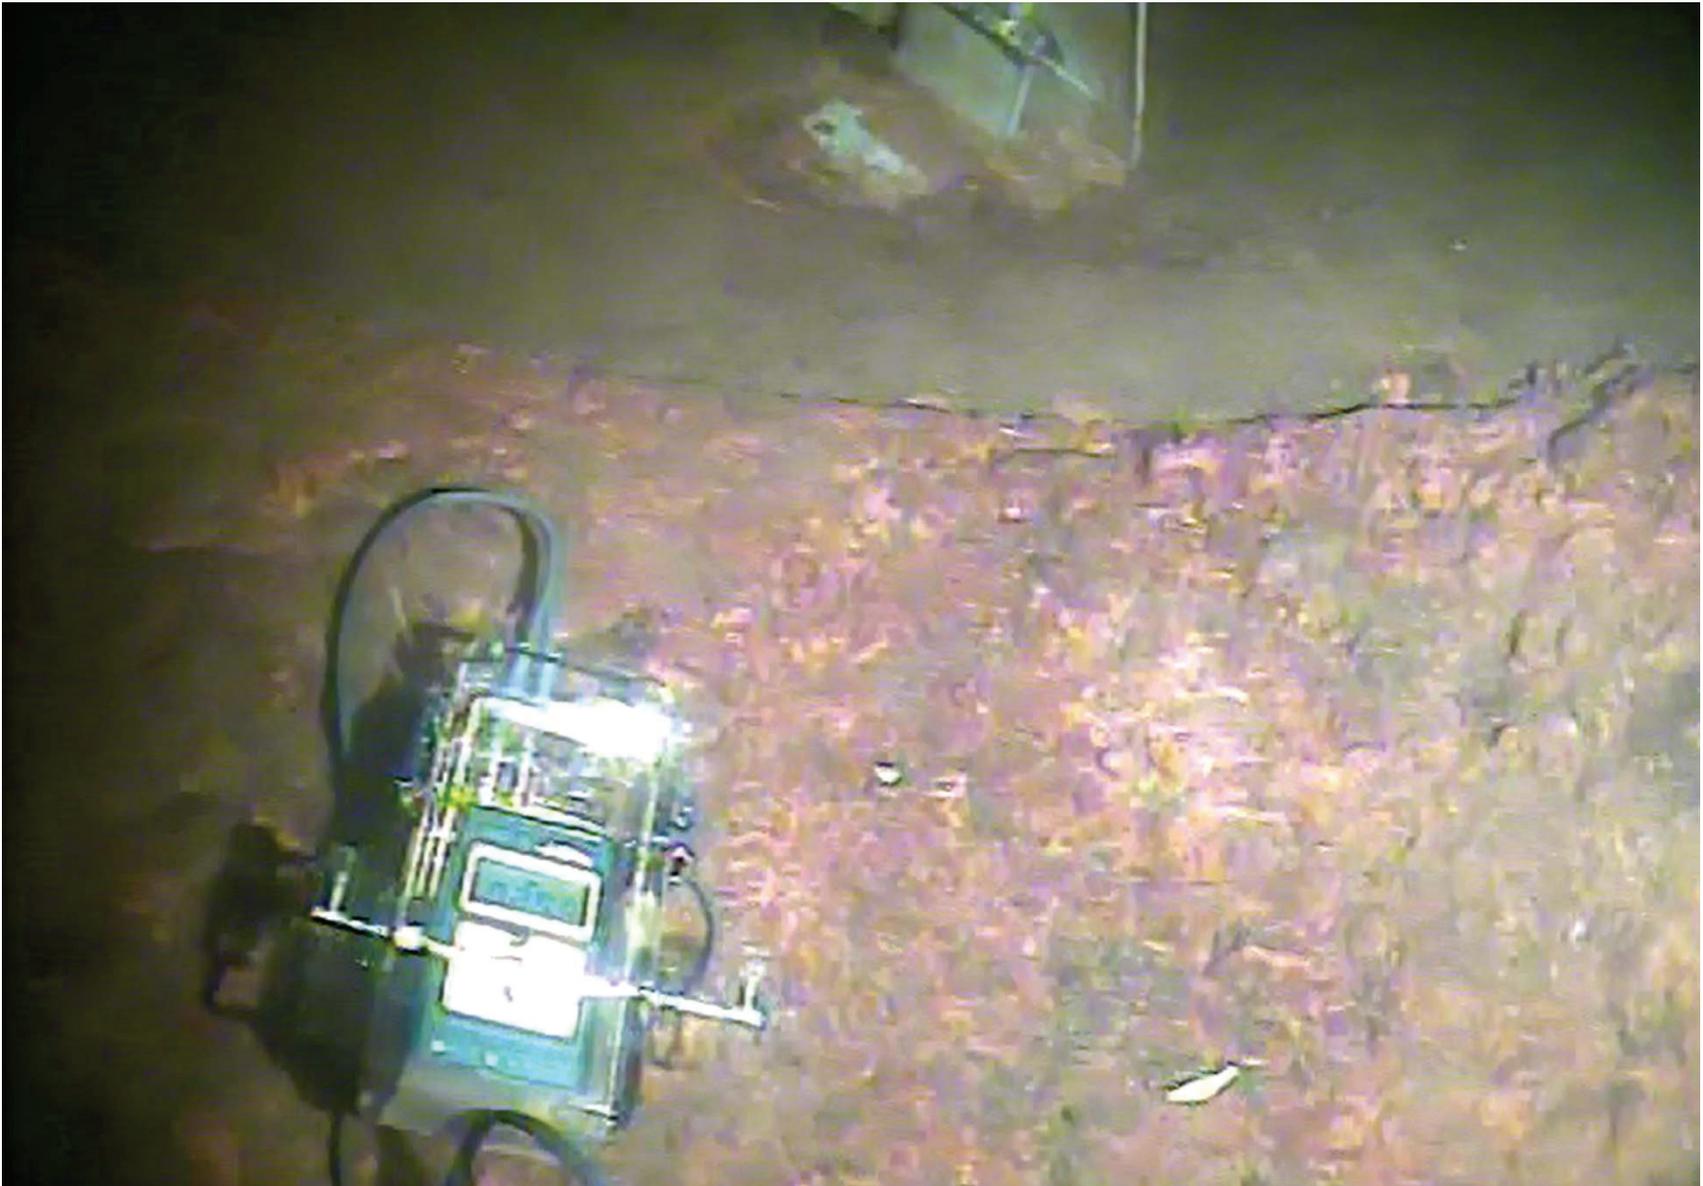
Each of the three parallel deteriorated pipe sections connects downstream to newer sections of cement-mortar-lined steel pipe. Observations were extended to these newer sections. The cement mortar lining and stainless steel mixer components inside the newer (1980) steel pipe in the Chlorine Injection Room is in good condition. The cement mortar lining is mainly intact. Some localized rust staining was observed at the stainless steel static mixer connection points to the two municipal supply pipelines. As stated previously, the static mixers are only installed in the two municipal supply pipelines. See Photographs B-10 and B-11 (Appendix B).

Photo 1. Interface Between Older and New Pipes

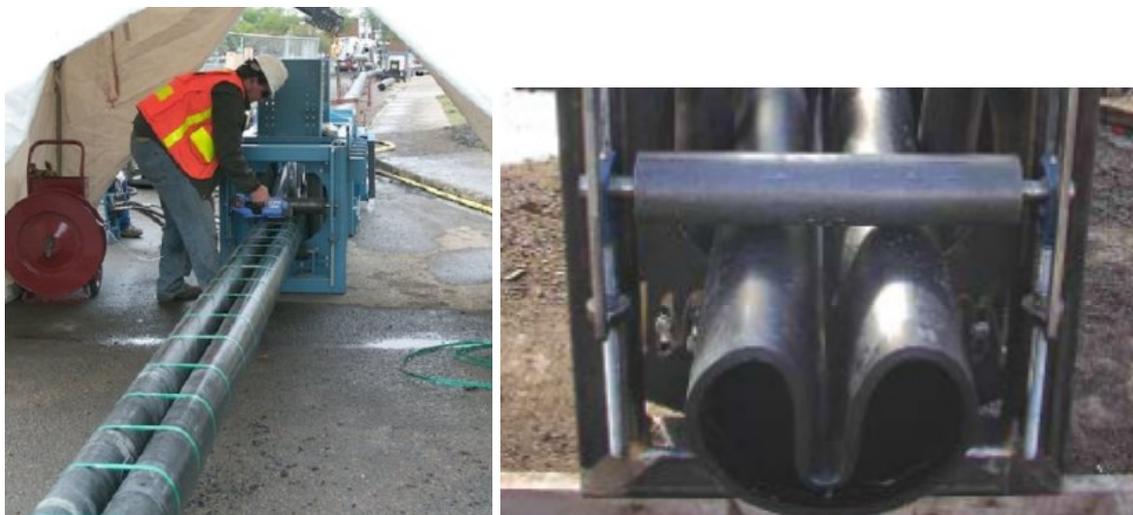
**Figure 6 - Rehabilitation with Insituform Polyfold Technology**

This Insituform proprietary installation process is similar to cured in place pipe liner but uses a close fitting polyethylene pipe that is custom designed to match the existing conditions for the pipe to be rehabilitated. The pipe is fused together in the length required for the project and then held together by bands that are broken after installation into the host pipe, as shown in Figure 6. This process allows for any length of pipe to be used for installation. The ends of the pipe would be sealed with an end seal to provide a watertight connection. The polyethylene wall thickness is designed to meet the operating and surge conditions to provide the required strength to span openings. Any flow loss from the reduced diameter is usually recovered by the improved flow characteristics.

This method has the advantage that no time is required for curing the pipe. The work would still need to be conducted in phases to allow for the installation in each pipe separately, and it would require opening up holes in the walls of the Screen House to provide access for the folded pipe, and the removal of some trees from behind the Screen House to provide sufficient clear space to set up the equipment and laying out the pipe to be inserted. Once folded, the pipe becomes fairly rigid, and it is doubtful if sufficient clearance exists inside the Screen House

to allow for maneuvering the folded pipe into the host pipes for this concept to be employed. Consultation with a qualified contractor would be required before proceeding with this option to confirm that it is feasible.

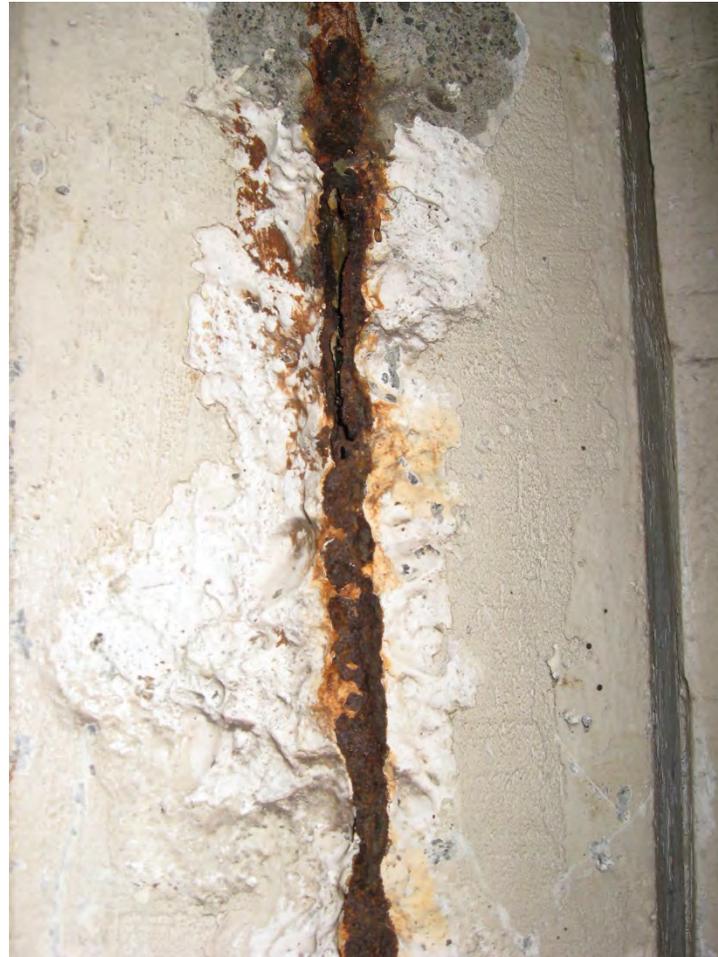
Photo B-17c. PM 132: Close-up view of the same location as shown in Photos B-17a and 17b, prior to painting. Photo date: 9-24-2013.

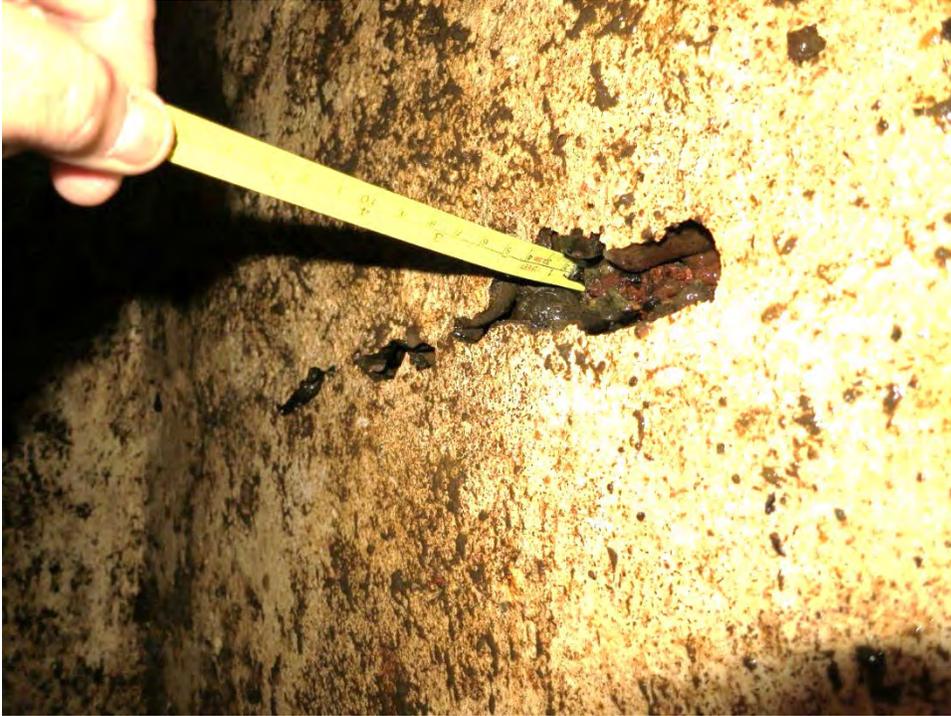
Photo B-19b. IMG\_1777: Outlet well cold joint line where voids in concrete from 1.5" -2" deep have formed. Photo date: 4-23-2014.

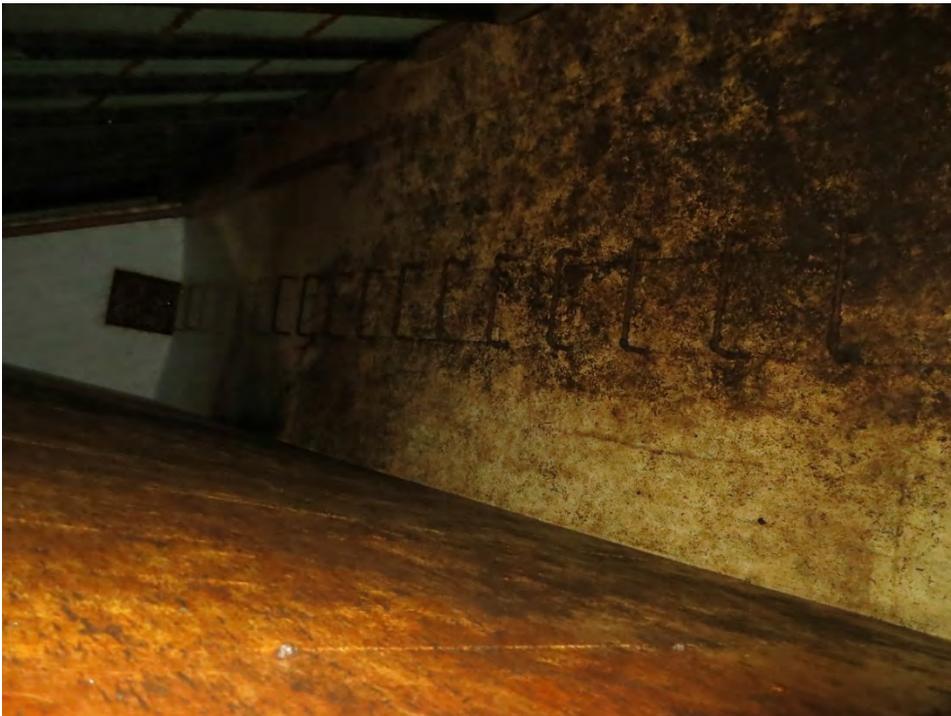
Photo B-24. IMG\_1825: Screen well (South side) walls with minor voids and underside of roof showing a whit coating. Photo date: 4-23-2014.

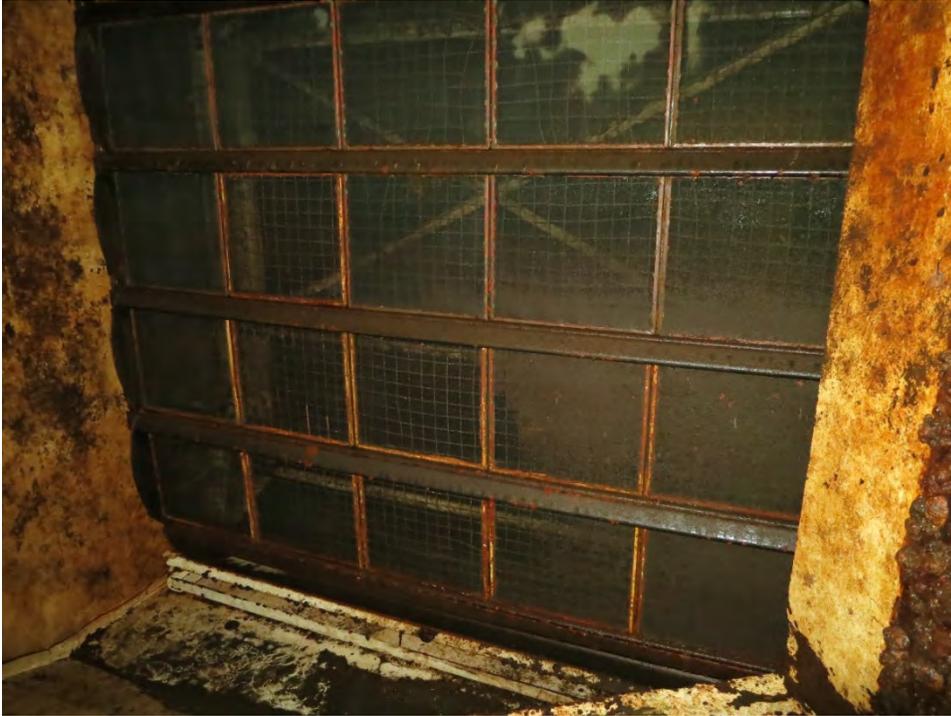
Photo B-25. IMG\_1823: Screen well (South side) walls near screen shows some erosion. Photo date: 4-23-2014.

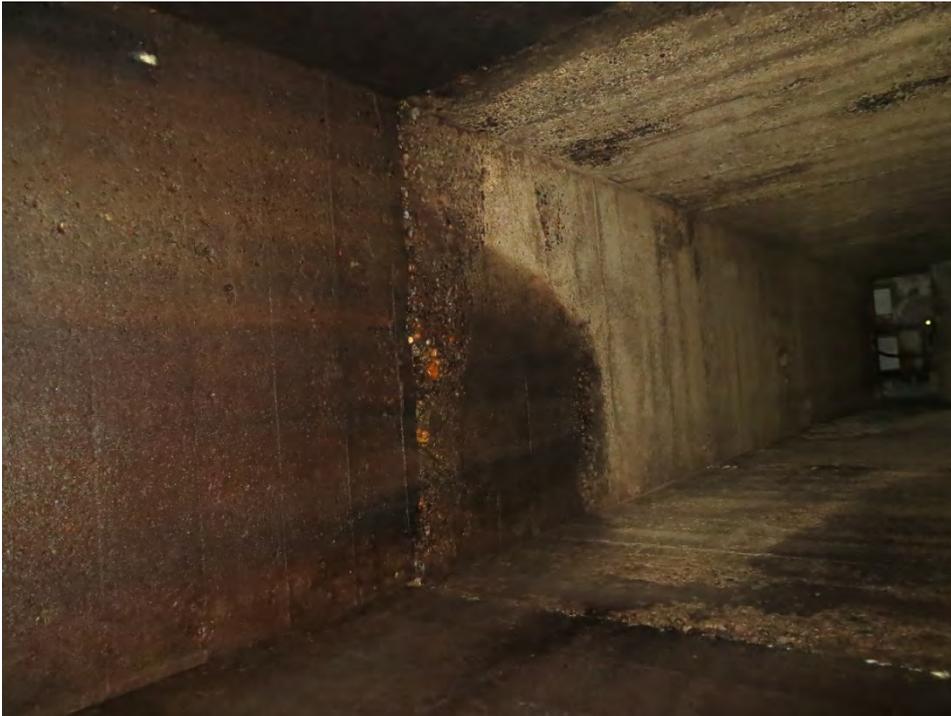
Photo B-30. IMG\_1836: Waste well wall eroded concrete at a cold joint or construction joint. Photo date: 4-23-2014.

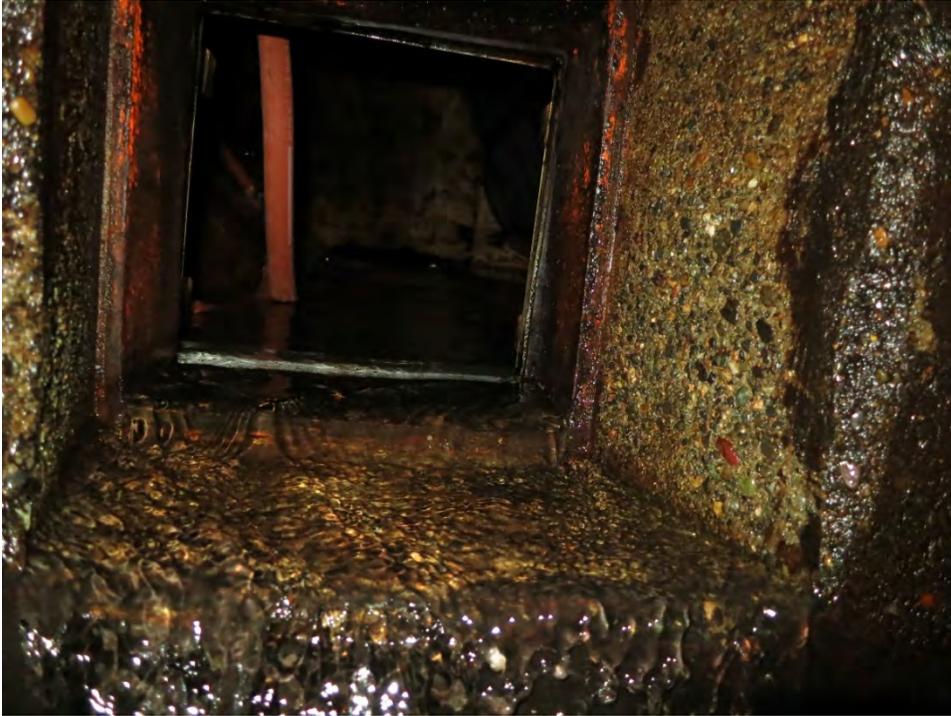
Photo B-31. IMG\_1844: Waste well surface eroded concrete around 12"x12" slide gate. Photo date: 4-23-2014.

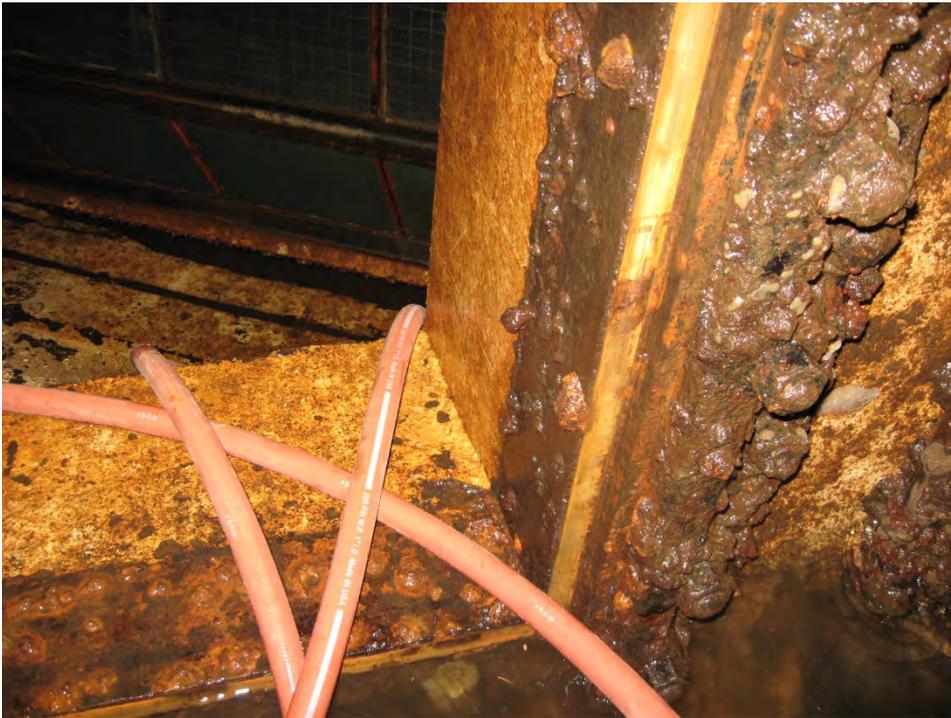
Photo B-33. Slide gate (1) wall thimble, guide and frame. Photo date: 4-23-2014.

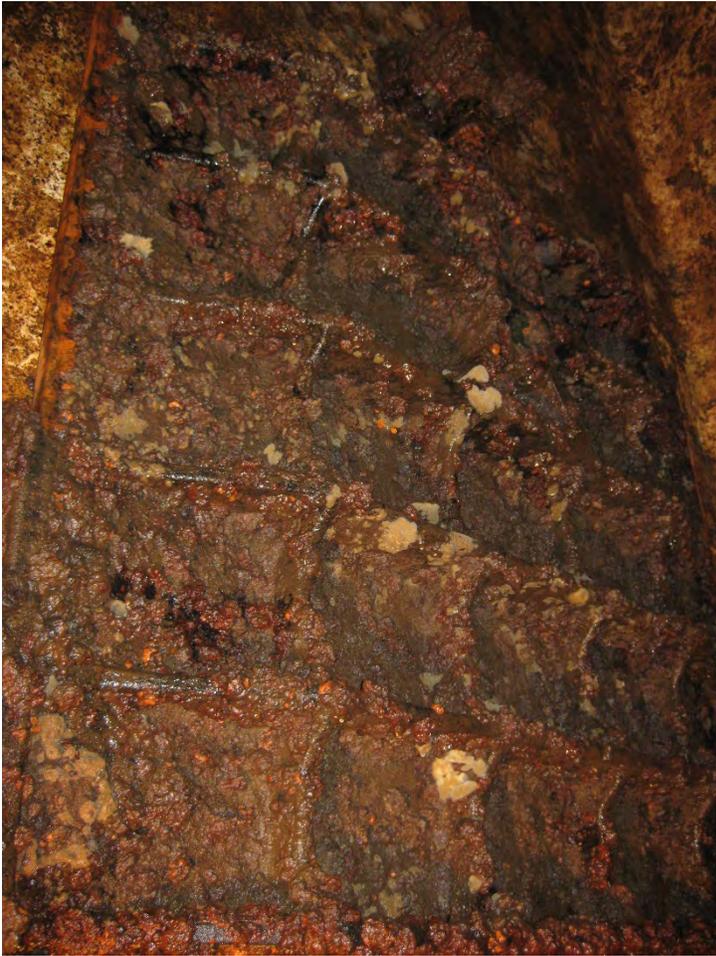
Photo B-34. Slide gate (2) in intake well. Photo date: 4-23-2014.

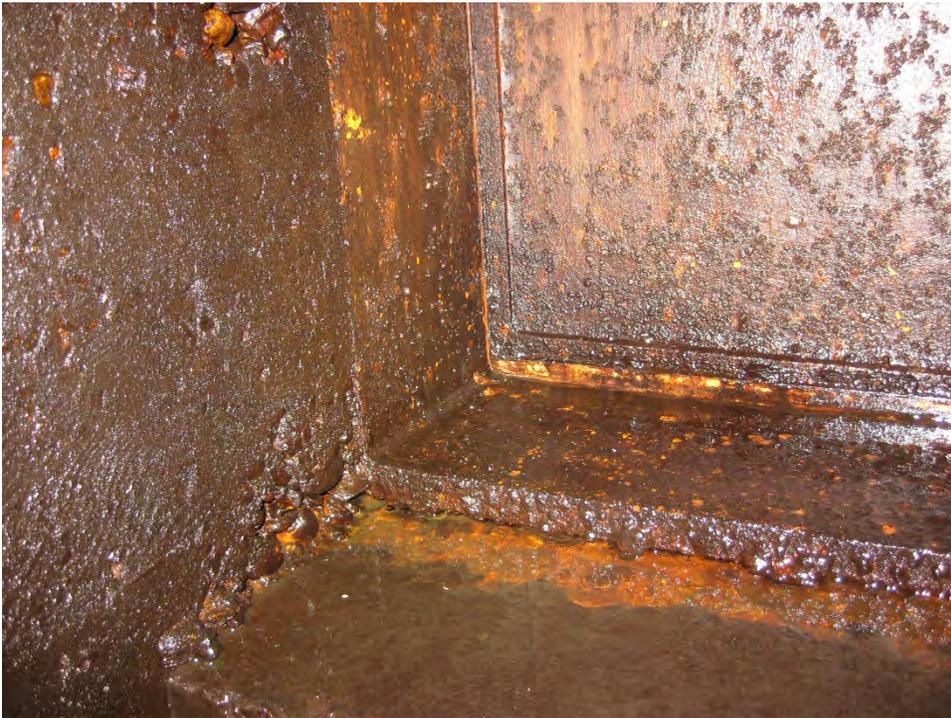
Photo B-35. Slide gate (3) downstream side and wall thimble. Photo date: 4-23-2014.

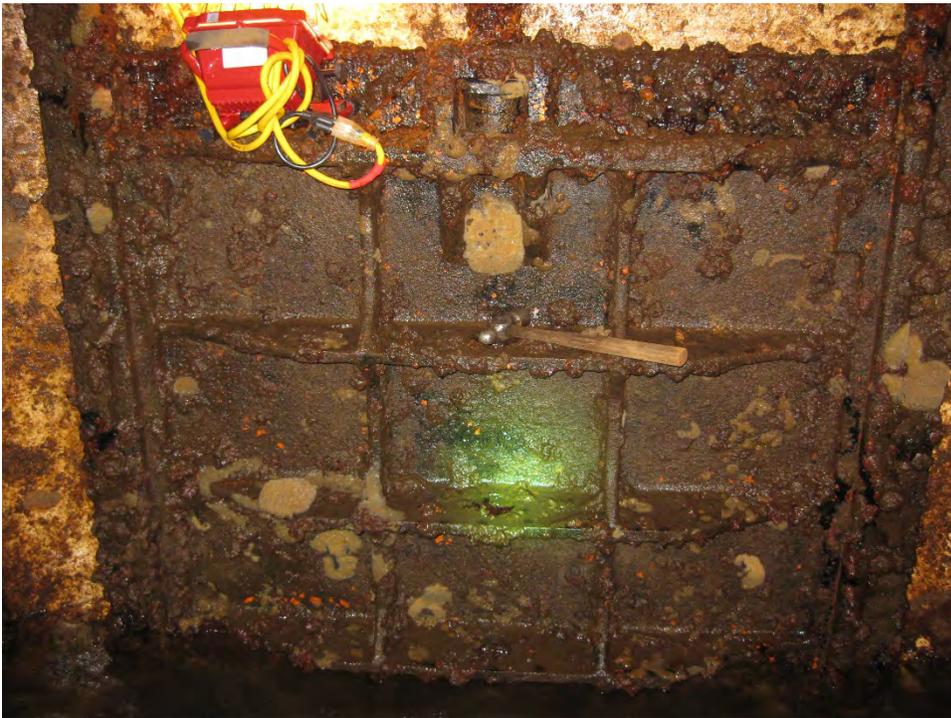
Photo B-36. Slide gate (3) in intake well frozen in closed position. Photo date: 4-23-2014.

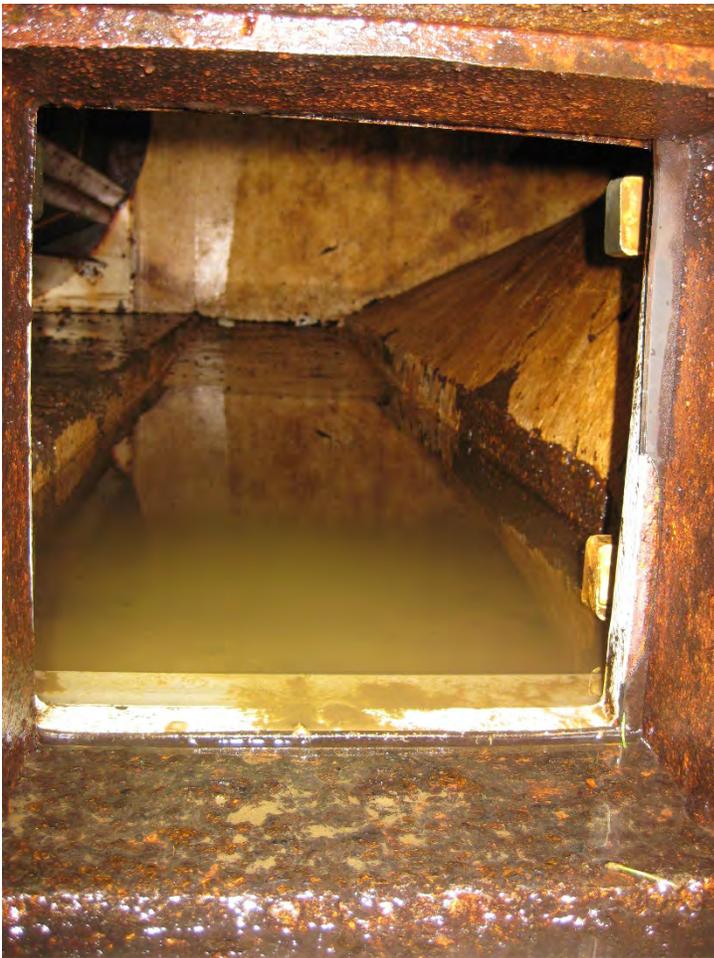
Photo B-39. Slide gate (5) wall thimble from downstream side. Photo date: 4-23-2014.

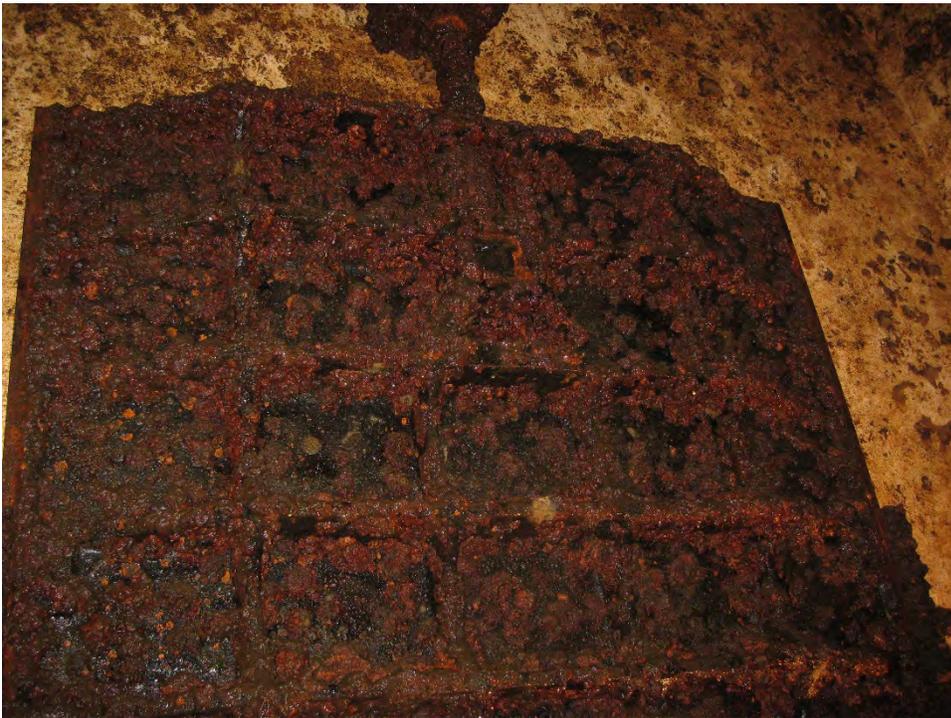
Photo B-40. Slide gate (6) in outlet well. Photo date: 4-23-2014.

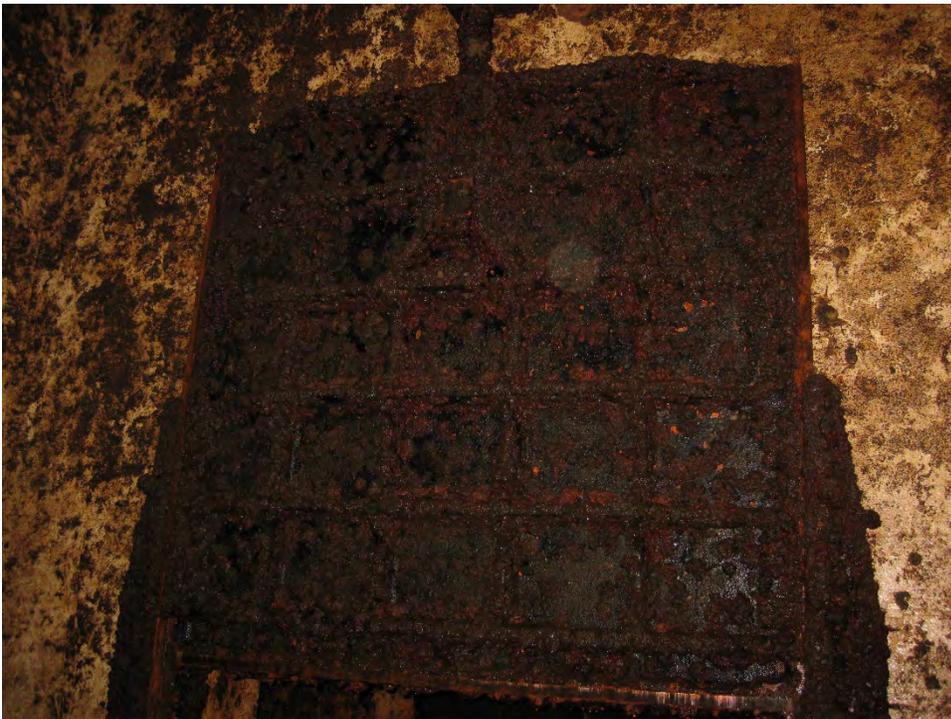
Photo B-41. Slide gate (7) in outlet well. Photo date: 4-23-2014.

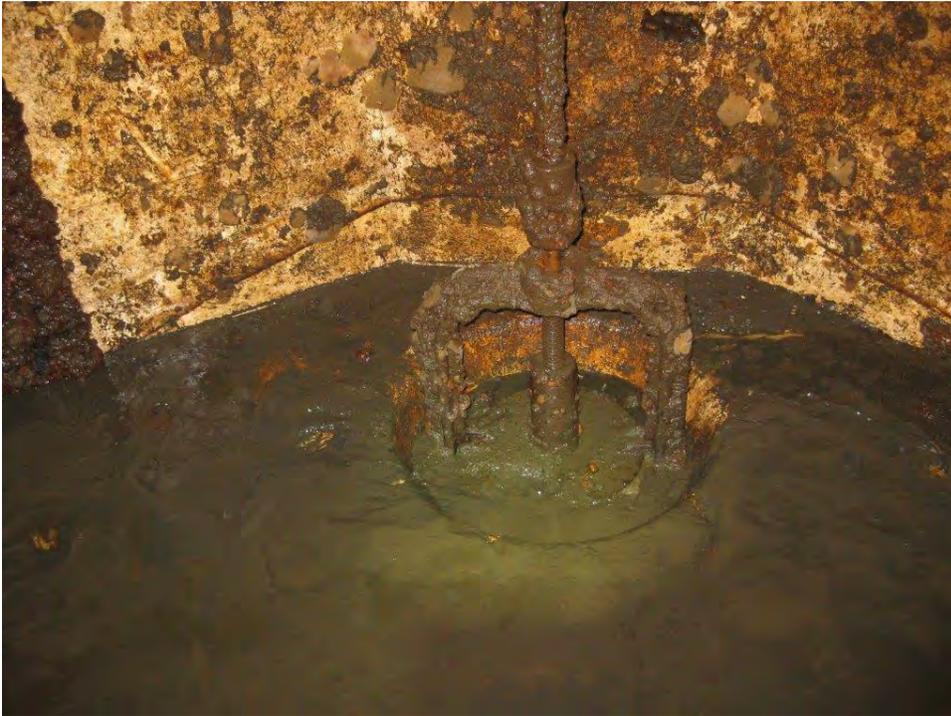
Photo B-42. Plug (mud) valve (8) in outlet well with detached operating stem. Photo date: 4-23-2014.

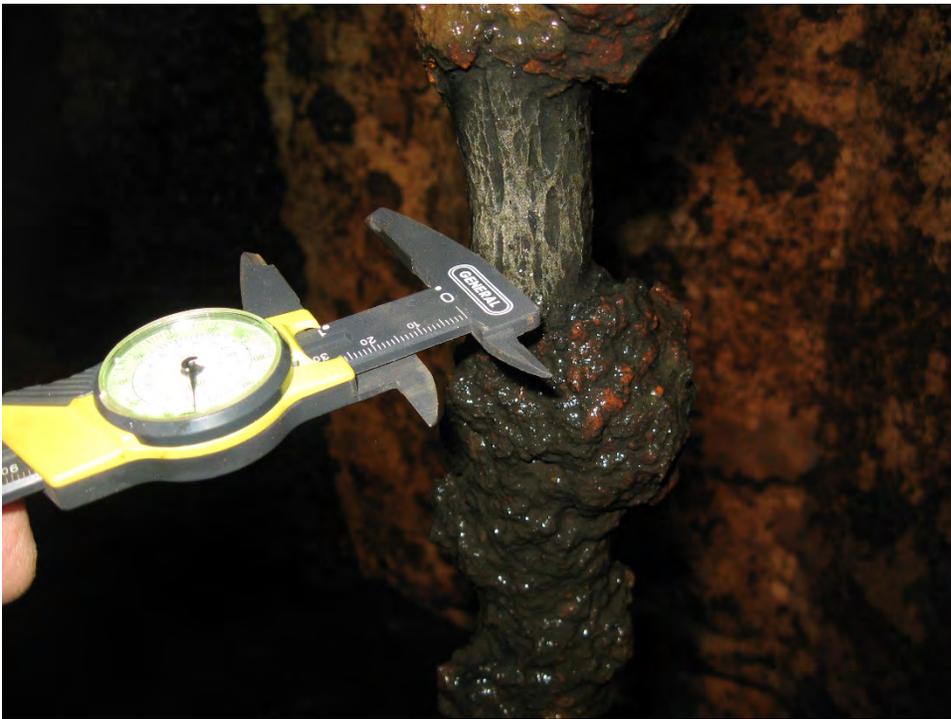
Photo B-43. Plug (mud) valve (8) operating stem. Photo date: 4-23-2014.

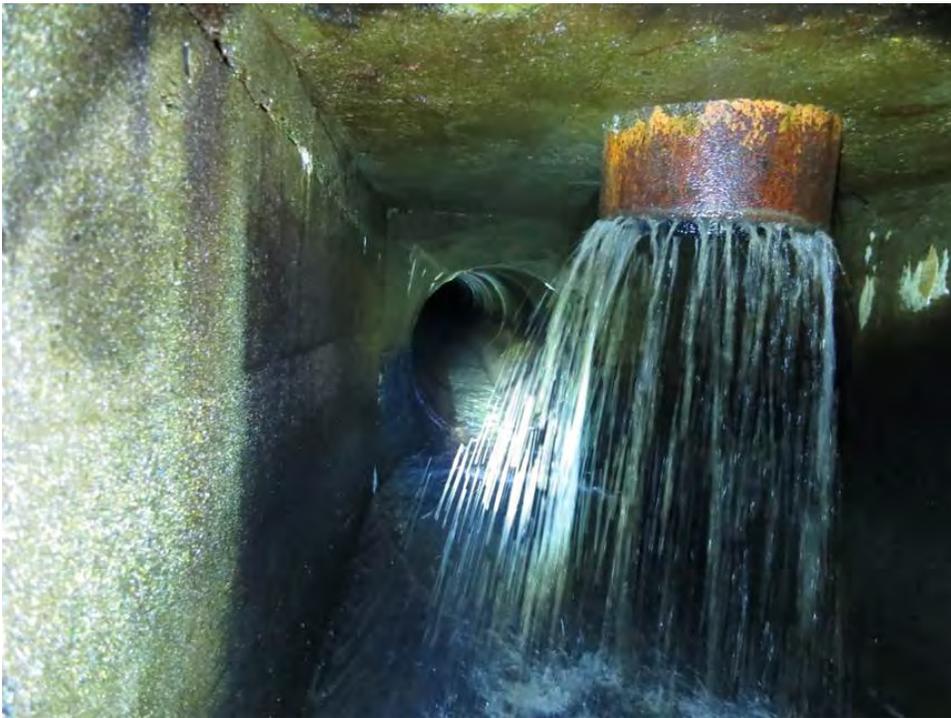
Photo B-44. Plug (mud) valve (8) outlet from below. Photo date: 4-23-2014.

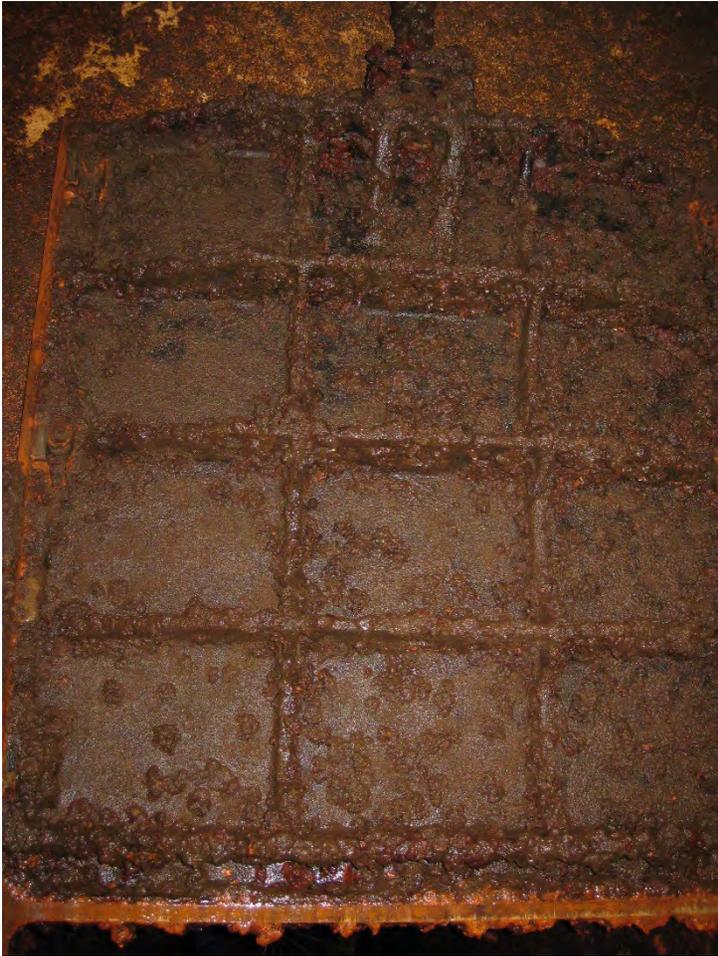
Photo B-45. Slide gate (9) in outlet well. Photo date: 4-23-2014.

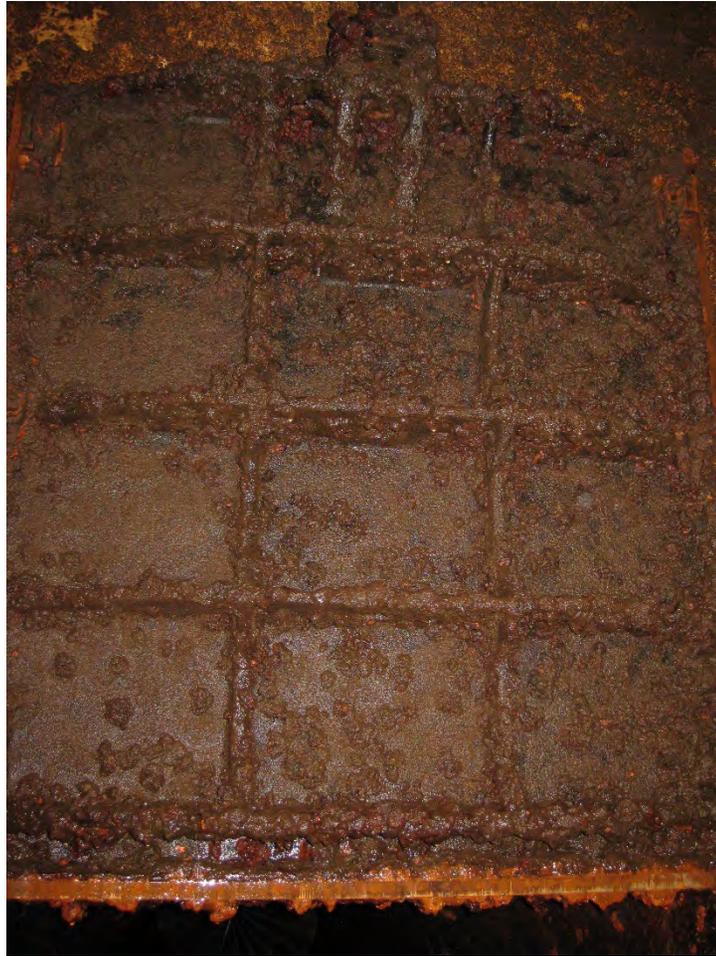
Photo B-46. Slide gate (10) in outlet well. Photo date: 4-23-2014.

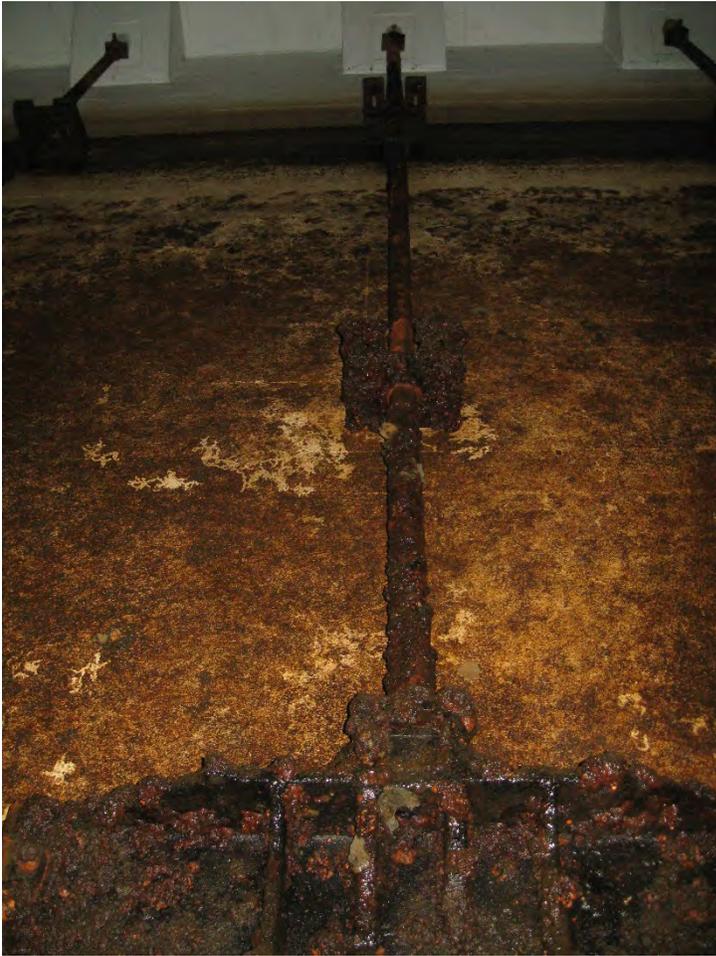
Photo B-47. Slide gate (10) operating stem. Photo date: 4-23-2014.

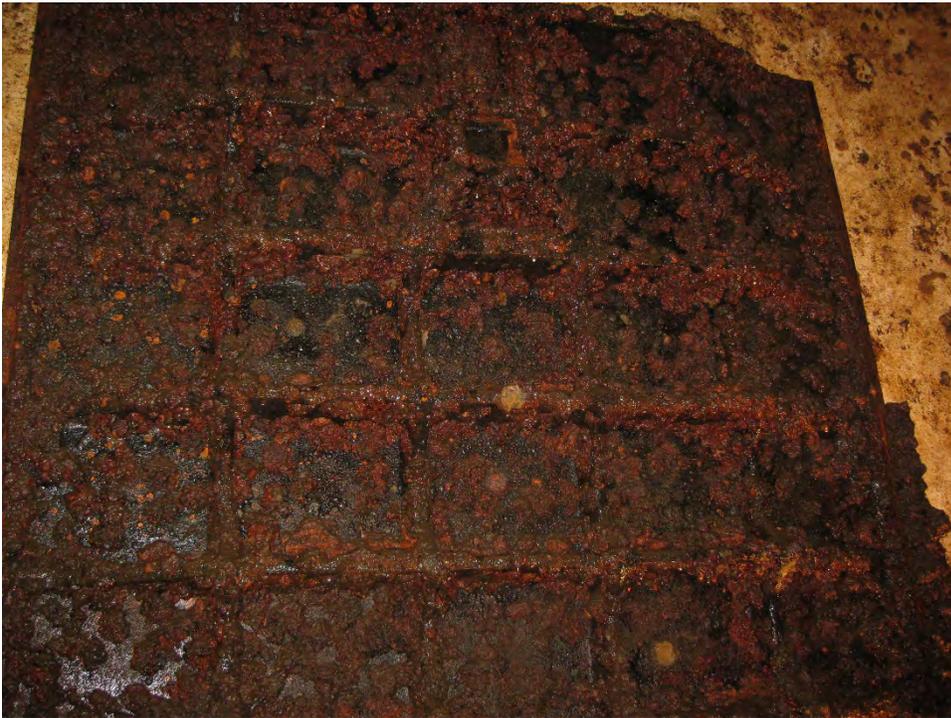
Photo B-48. Slide gate (11) in outlet well. Photo date: 4-23-2014.

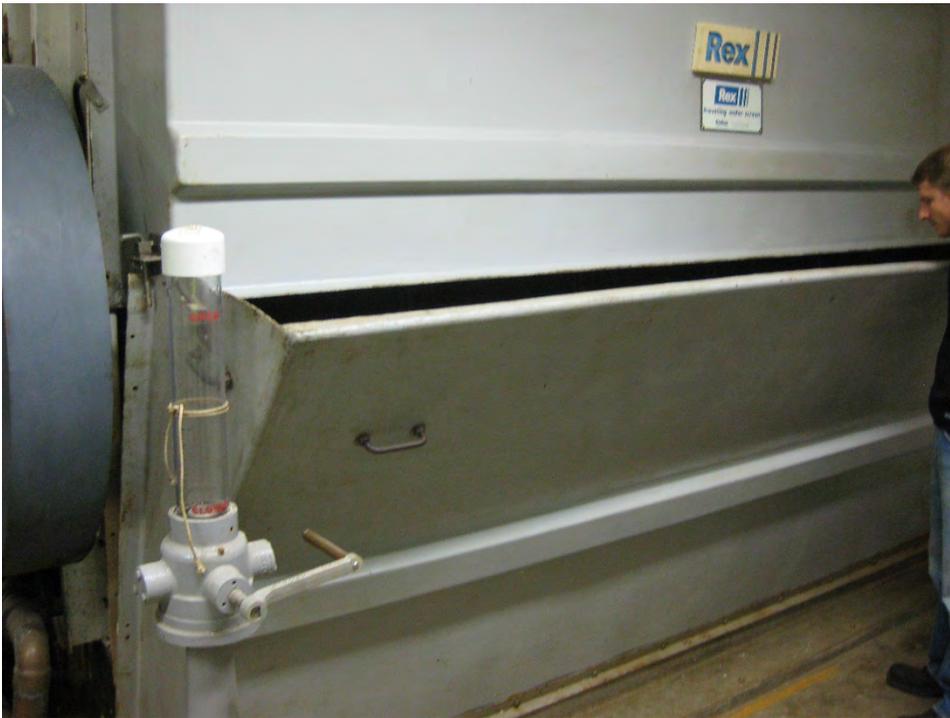
Photo B-49. Closeup view of traveling screen (right) at deck level. Photo date: 4-23-2014.

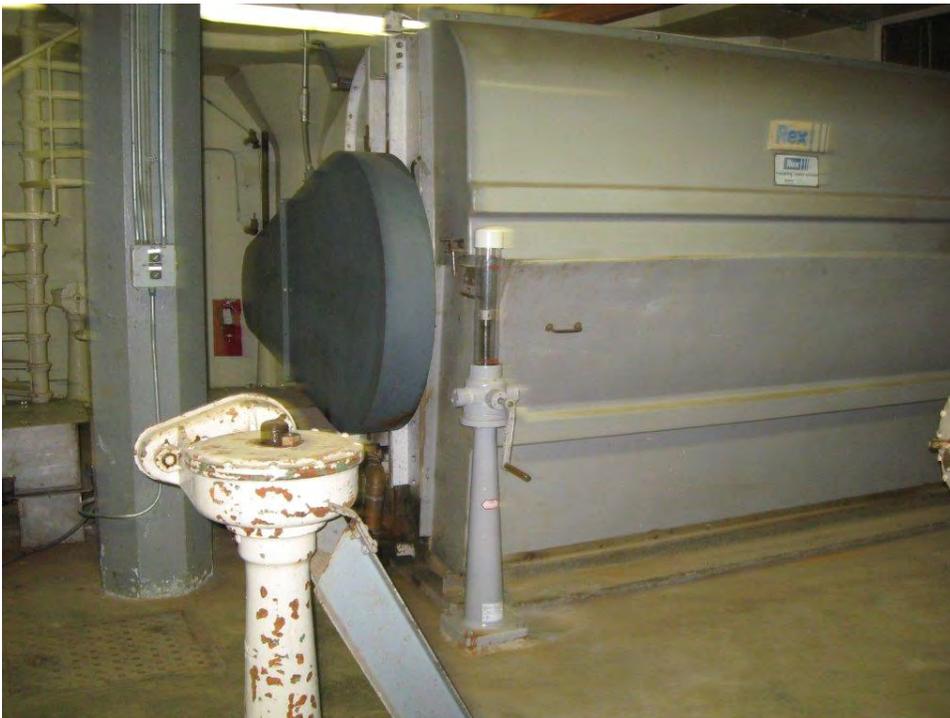
Photo B-50. Traveling screen at deck level. Photo date: 4-23-2014.

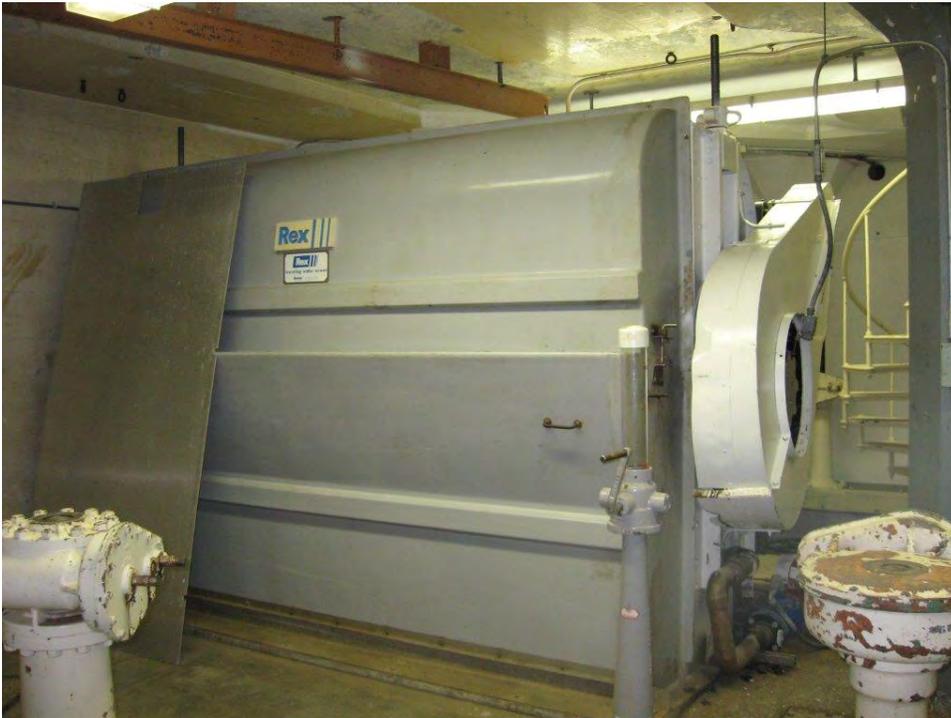
Photo B-51. Opposite view of traveling screen at deck level. Photo date: 4-23-2014.

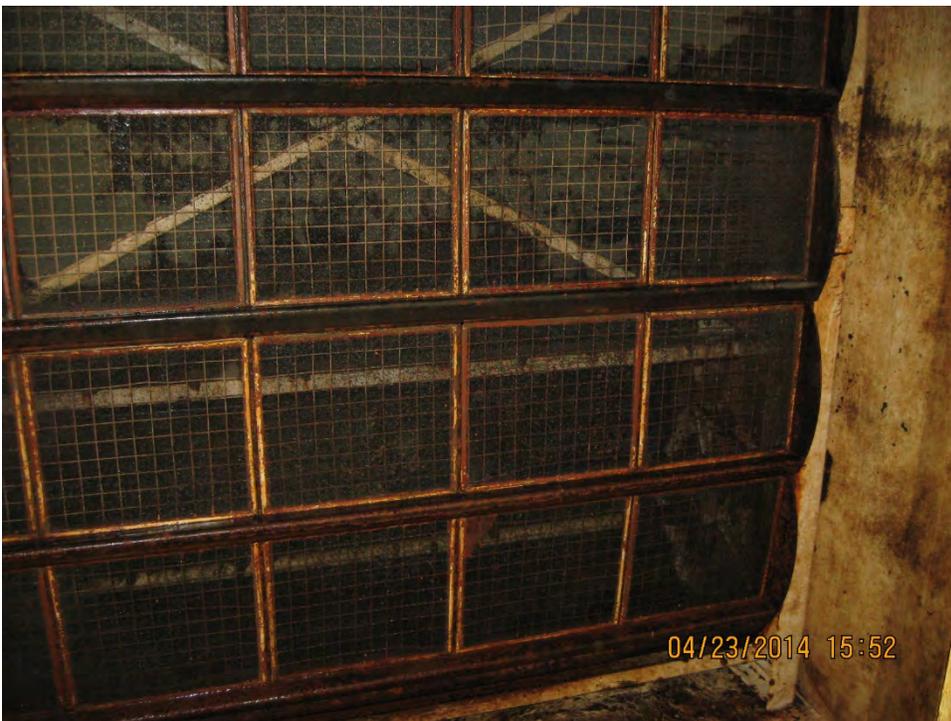
Photo B-52. Traveling screen at screen well invert. Photo date: 4-23-2014.

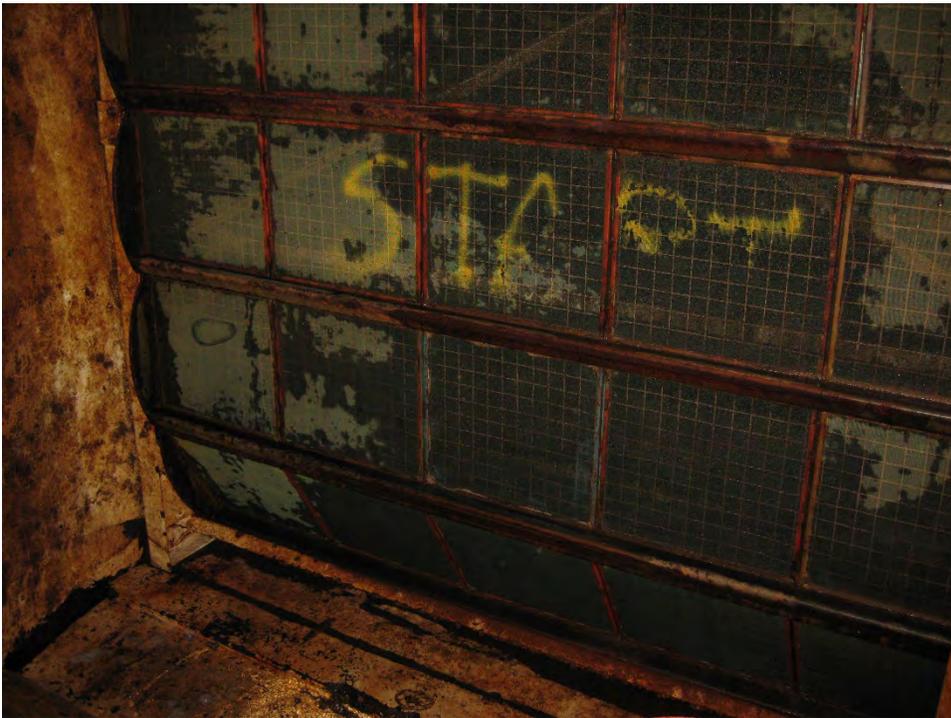
Photo B-53. Traveling screen (right) at screen well invert. Photo date: 4-23-2014.

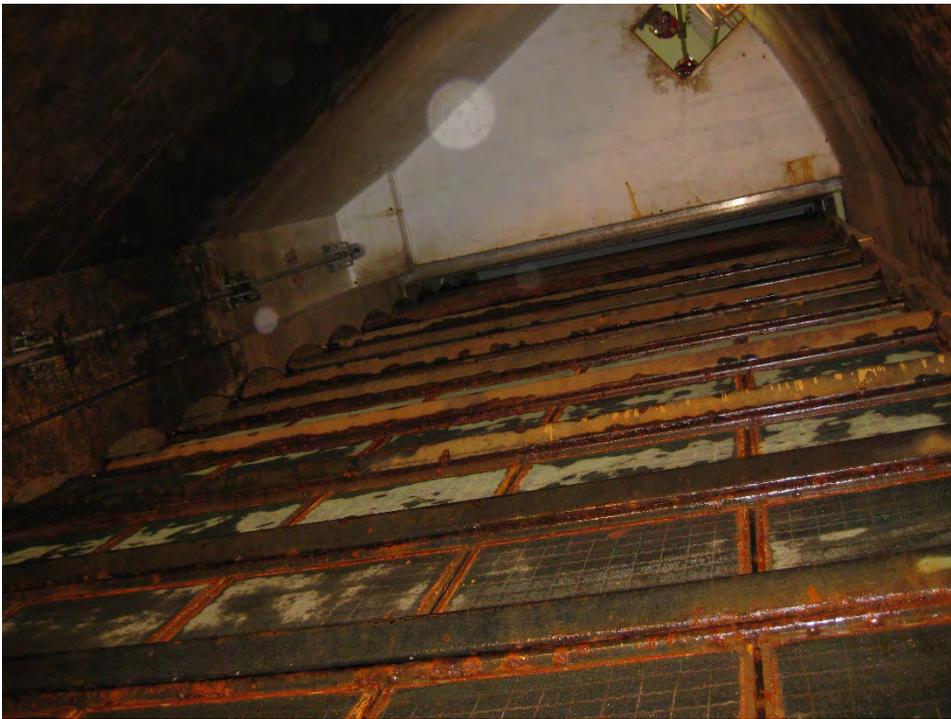
Photo B-54. View upward of traveling screen from screen well invert. Photo date: 4-23-2014.

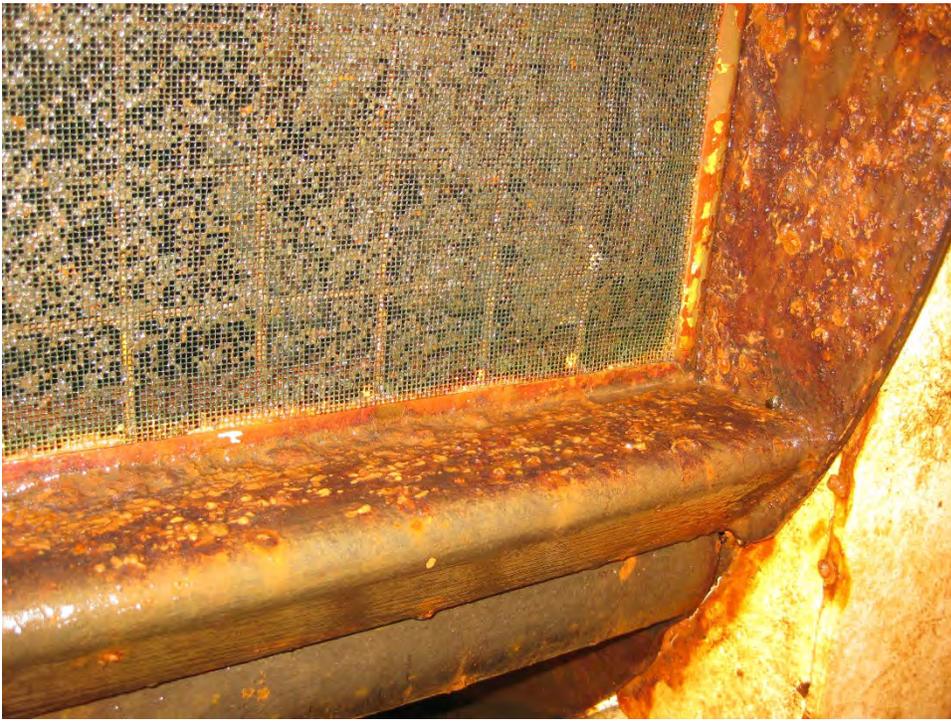
Photo B-55. Closeup view of traveling screen fine mesh. Photo date: 4-23-2014.
