# City of Bellingham Screen House: Condition Assessment and Improvement Report (Task 3.8)

PREPARED FOR: City of Bellingham Project Team  
PREPARED BY: CH2M HILL Project Team  
DATE: November 7, 2014

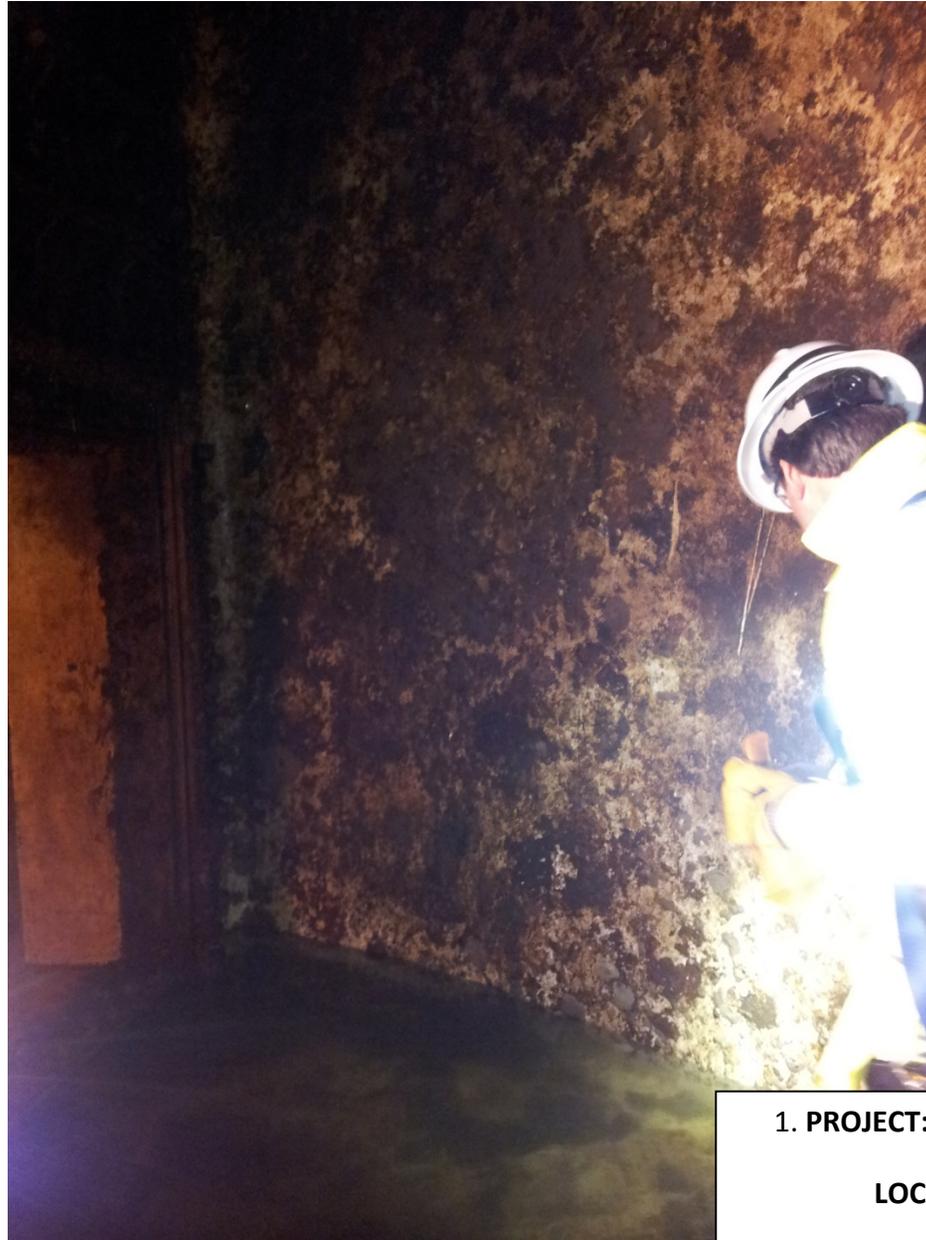
**1. PROJECT: Whatcom Falls Chlorine House**

Inlet well concrete wall located between water supply tunnel and screen room gate.

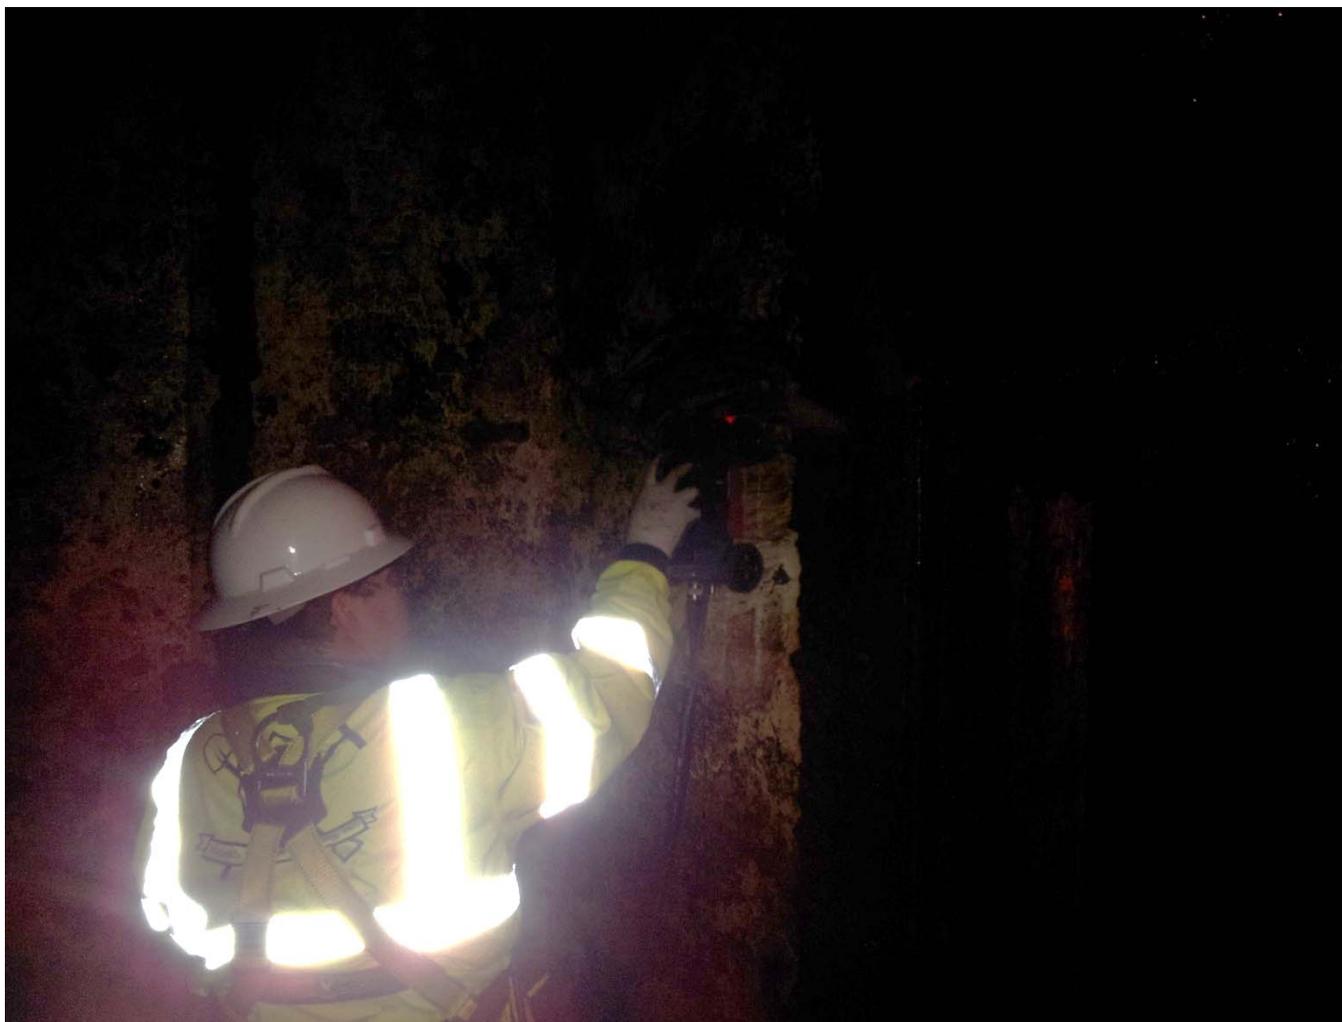
2. Vertical GPR scan being performed along wall adjacent to screen gate in outlet well.

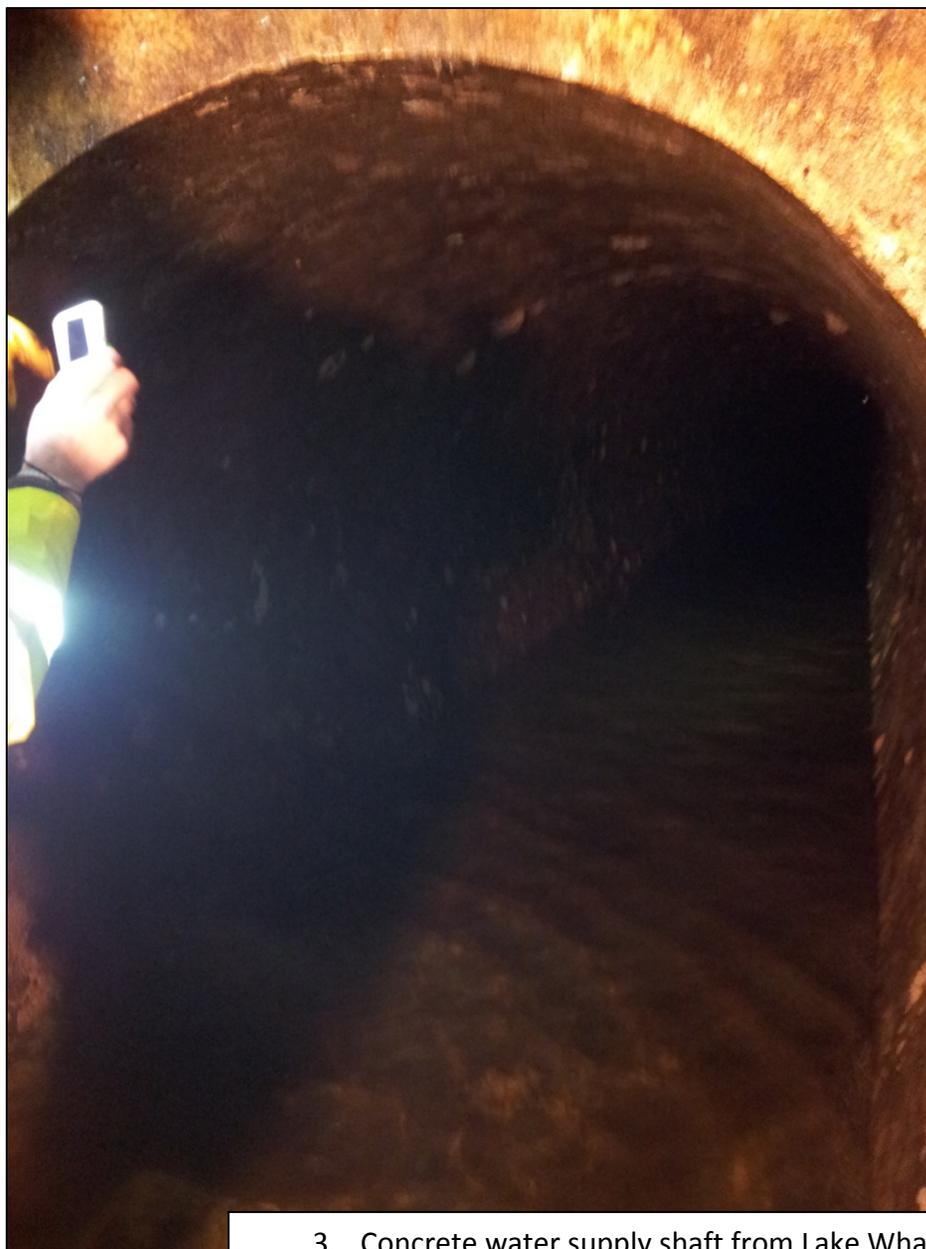
3. Concrete water supply shaft from Lake Whatcom to screenhouse and ultimately Bellingham treatment facility.

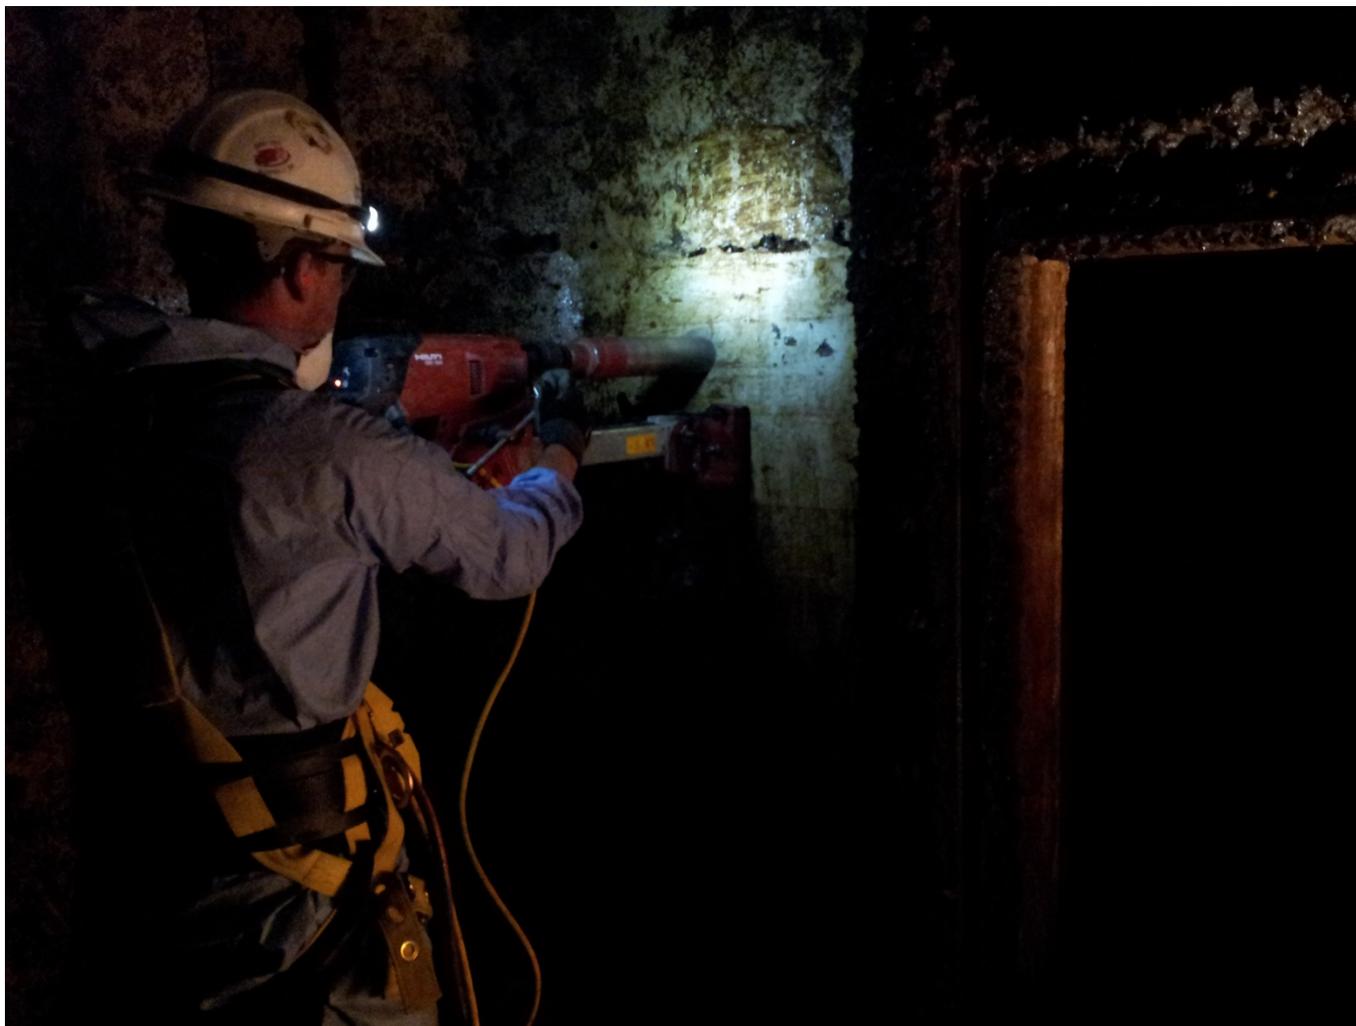
4. Reinforced concrete basement wall at chlorine house outlet well cored for compression testing.
