**GEOTECHNICAL INVESTIGATION  
& GEOHAZARD REPORT  
JONES EDGEMOOR ESTATE  
PROPOSED 38-LOT PLAT DEVELOPMENT  
VIEWCREST ROAD, BELLINGHAM, WA**

Subject: **Geotechnical Investigation & Geohazard Assessment**  
**Proposed 38-Lot Plat - Jones Edgemoor Estate**  
Viewcrest Road, Bellingham, WA

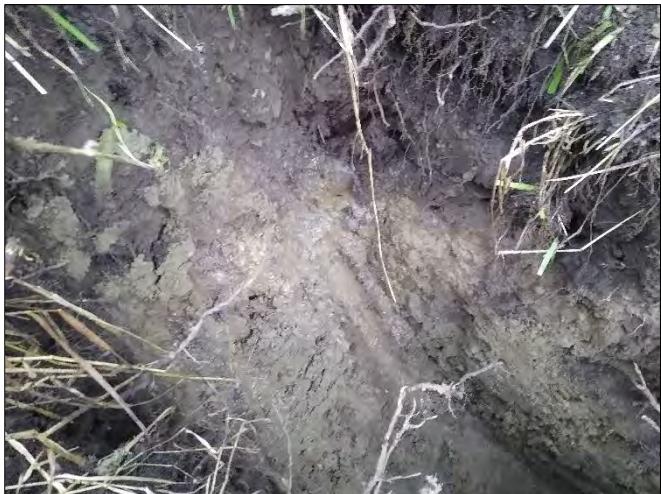
**Photo 1: TP1**

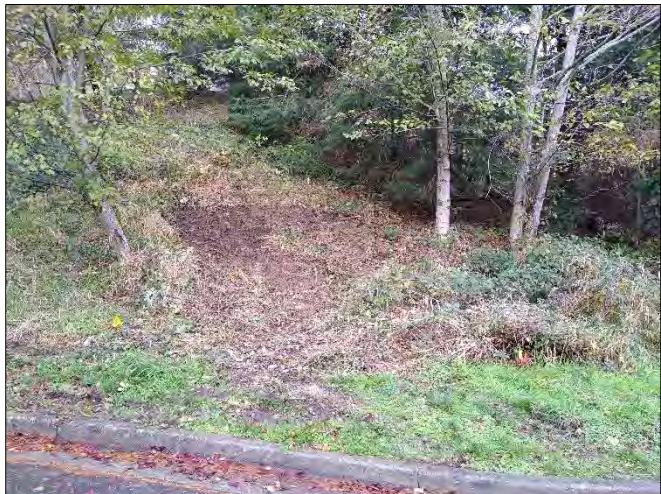
**Photo 2: TP1 Location**

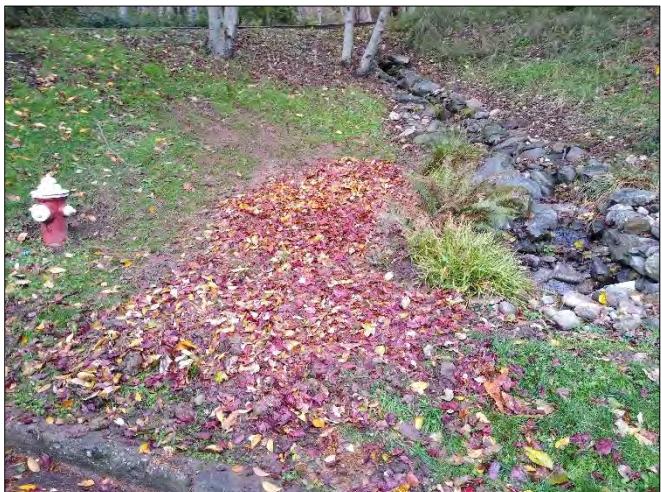
**Photo 5: TP2 Location & Site Restoration**

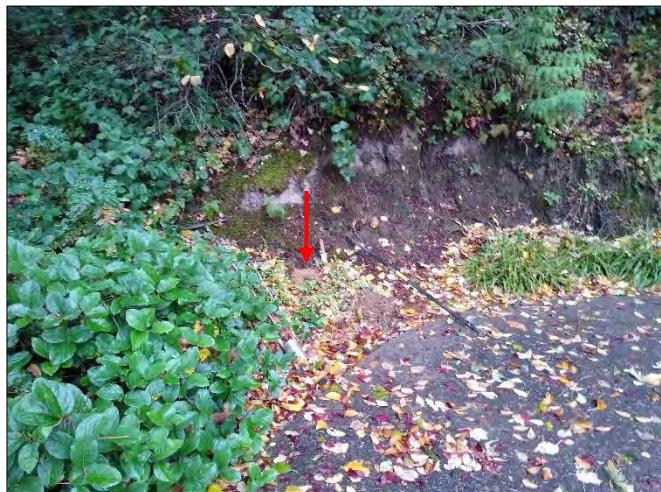
**Photo 6: HA-1 Location**

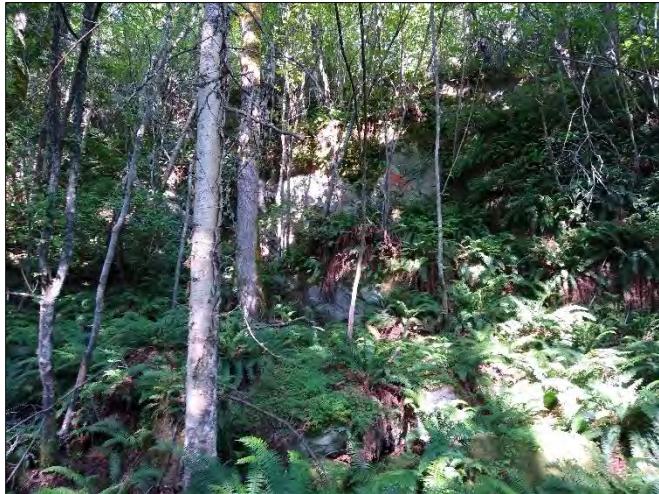
**Photo 1: Northern Part of NW Bedrock Face**

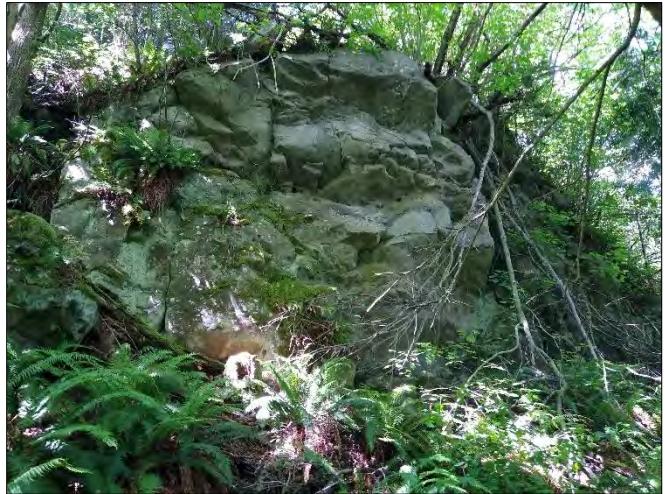
**Photo 2: Southern Part of NW Bedrock Face**

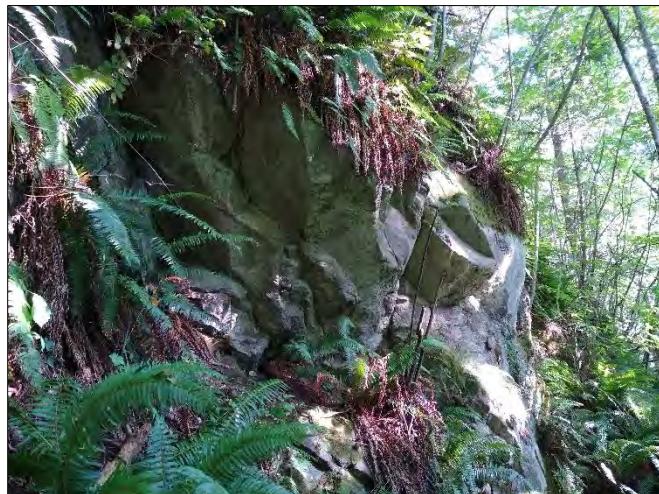
**Photo 3: Northern Part of NW Bedrock Face**

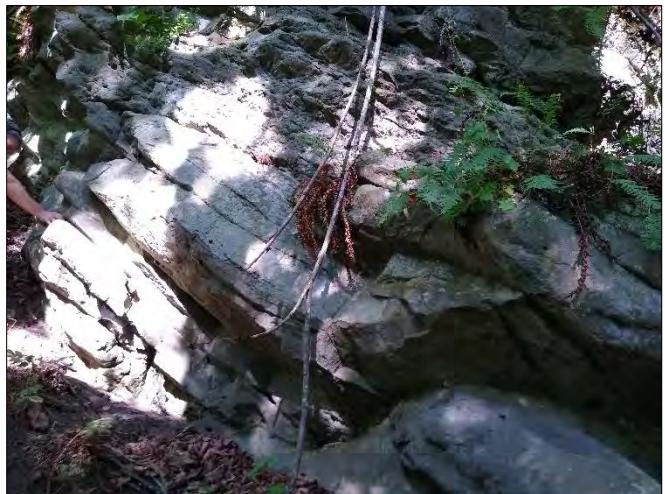
**Photo 4: Northern Part of NW Bedrock Face**

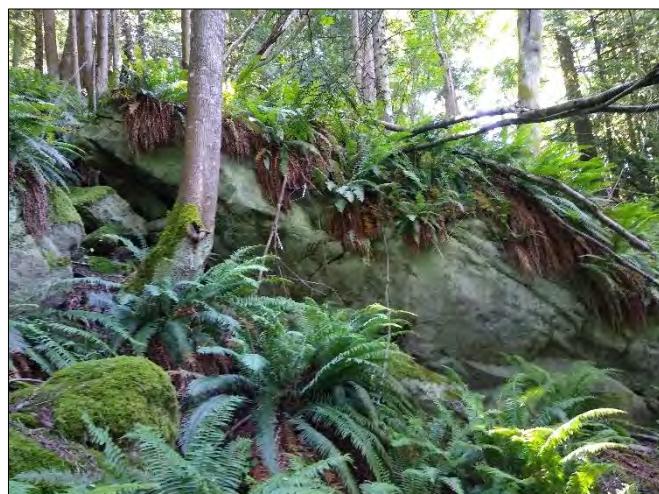
**Photo 5: NW Forested Slope**

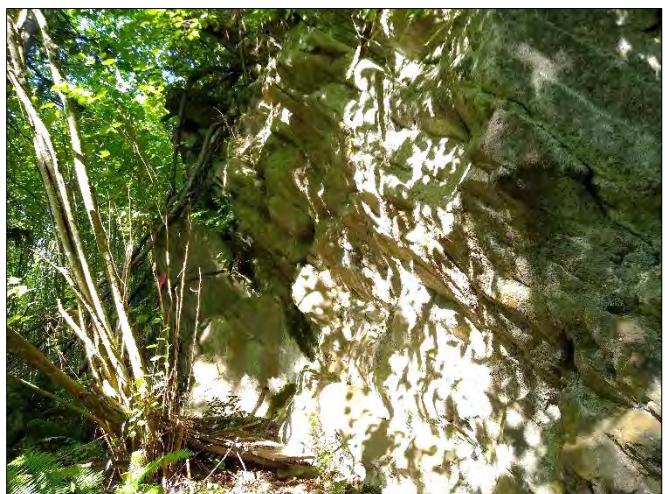
**Photo 6: Central Area of NW Bedrock Face**

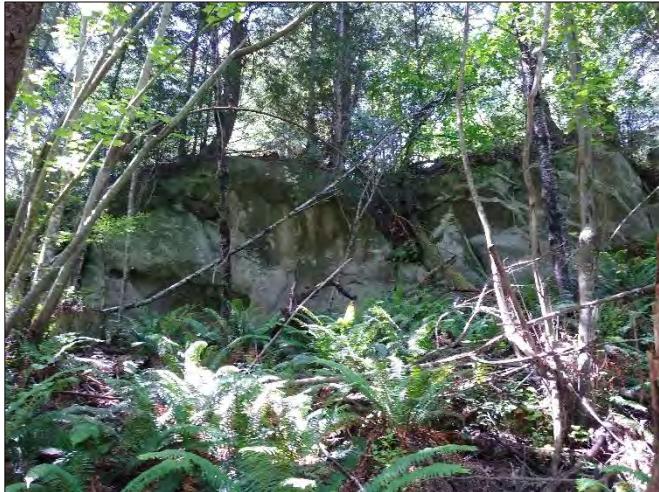
**Photo 7:** West-Central Bedrock Faces; West Outcrop

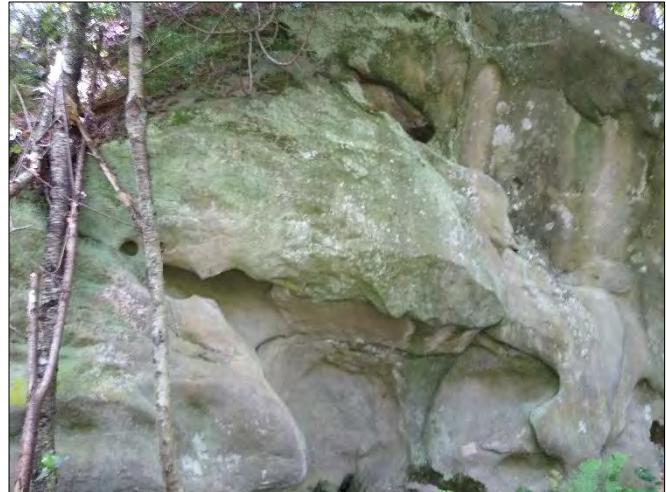
**Photo 8:** West-Central Bedrock Faces; West Outcrop

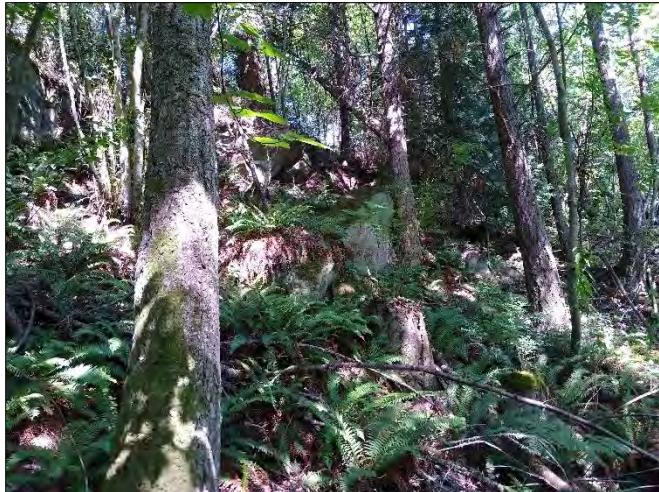
**Photo 9:** West-Central Bedrock Faces; West Outcrop, Northern Slope Area

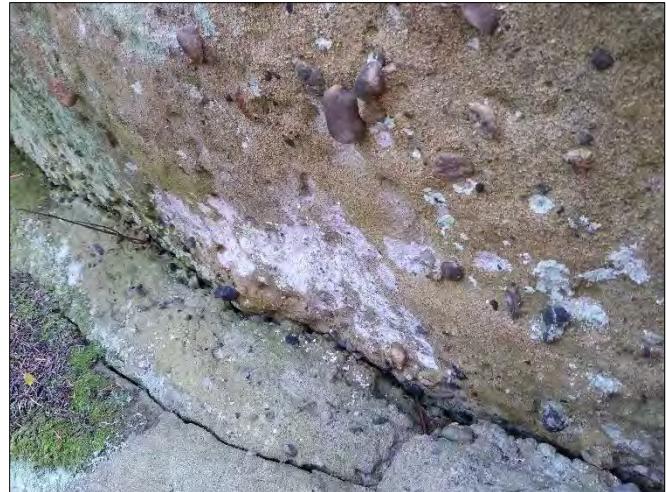
**Photo 10:** Conglomerate Bedrock Exposure; SW Project Area
